- Replacing GSM-R Cab Radios
- VSWR Testing of the Antenna Cable
- Siemens Technical Help Line

Please ensure that the subject title of the e mail is "GSM-R Bulletin 40"

Introduction: Observations of GSM-R Cab Radio maintenance procedures has identified useful lessons learnt when replacing GSM-R Cab Radios and when VSWR testing of the antenna and cable. This Guidance & Advisory note does not remove the accountability of maintainers complying with their company Vehicle Maintenance Instructions (VMI) at all times

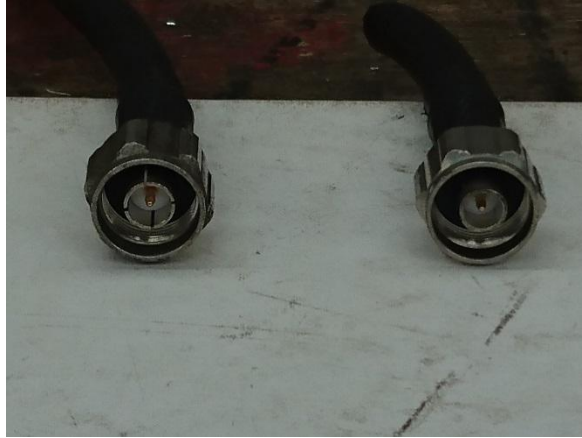
Maintenance Activity	Observations	Impact
Connecting / disconnecting of the coaxial cable N type connector to Antenna	Overtightening or misalignment of the N type connector can cause the centre pin of the male N type connector to be bent or pushed back. Overtightening can also cause damage to the connector screening. Under-tightening of the N type connector causing the centre pin of the connector to not correctly mate. None of the above is normally experienced when connected to VSWR Bird Antenna meter as not over tightened.	Loss of network with "Searching for Network" displayed on DPC.

The above photo shows the connector on the right that was connected to the antenna, showing the inner shield surround closed up due to being over tightened.

For comparison the connector to the left was connected to the radio unit. Note that the four segments of the shield surround are visible as they have not been crushed together due to being overtightened.

- The torque settings for Gland Box securing nuts are 4Nm.
- There is no Coaxial Cable Plug Torque Setting, it is recommended to be "Finger Tightened".
- Maintainers are advised to check the above observations during the fault finding process.

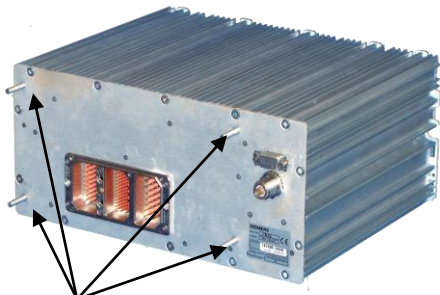
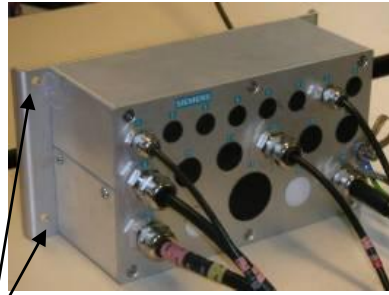
Maintenance Activity	Observations	Impact
Connecting the ARINC connector (Gland Box) to GSM-R Cab Radio	Overtighten of the x4 M5 securing nuts. Loose – missing securing x4 M5 securing	Bent/pushed back pins on ARINC connector causing possible low audio and component interface failures

Cab Radio & Gland Box (ARINC Connector) fitment x4 securing points (Torque setting 4Nm)
