Information request

Reference number: FOI2018/0602 & FOI2018/00603

Please may I request the following Level Crossing Narrative Risk Assessment's

Please may I request the following Level Crossing Narrative Risk Assessment:

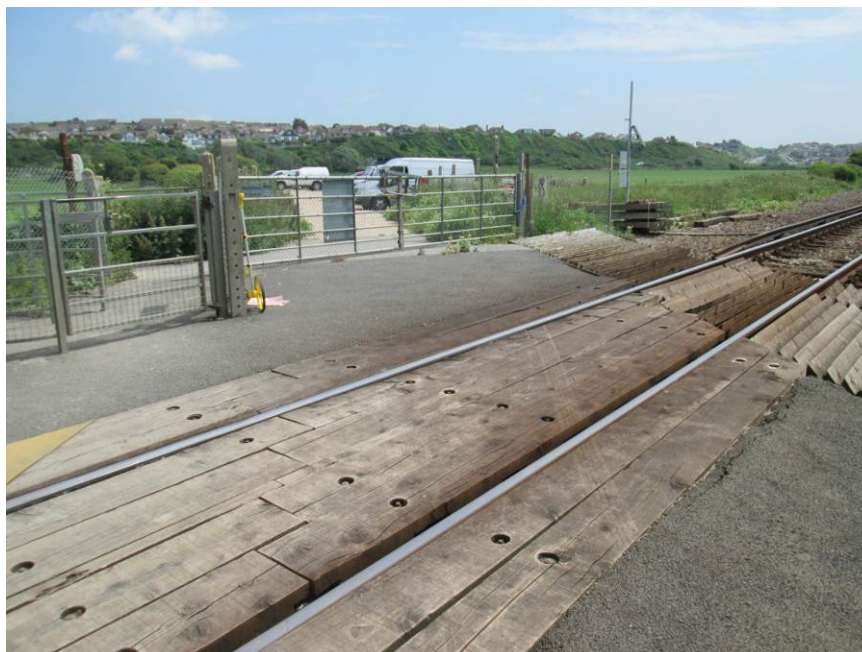
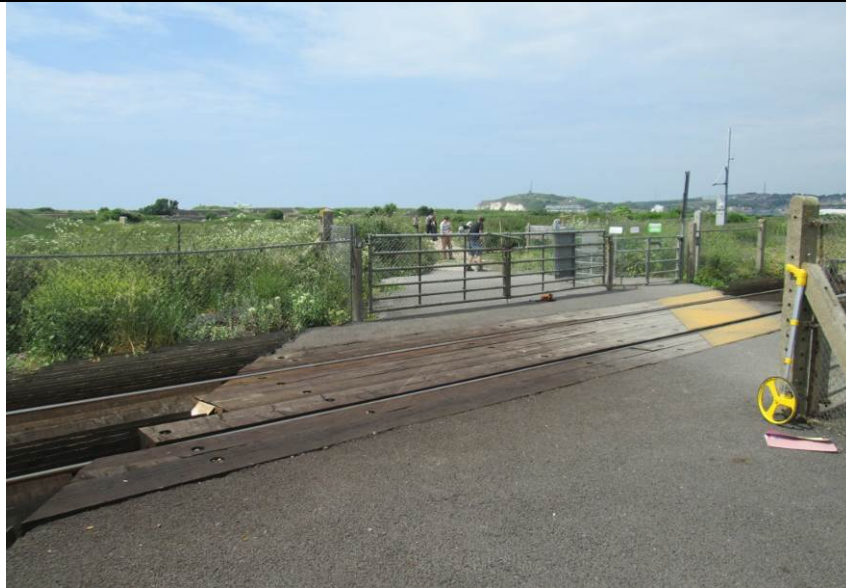
Photos here of both sides looking across the crossing, taken on a skew angle as the most direct route across the crossing for a vehicle user.

The crossing is protected by a chain link boundary fence line which encompasses the metal user work gates and the kissing gate accesses.

The crossing surface itself consists of suspended wood timbers which are in good condition and currently no wear is visible for need to replace.

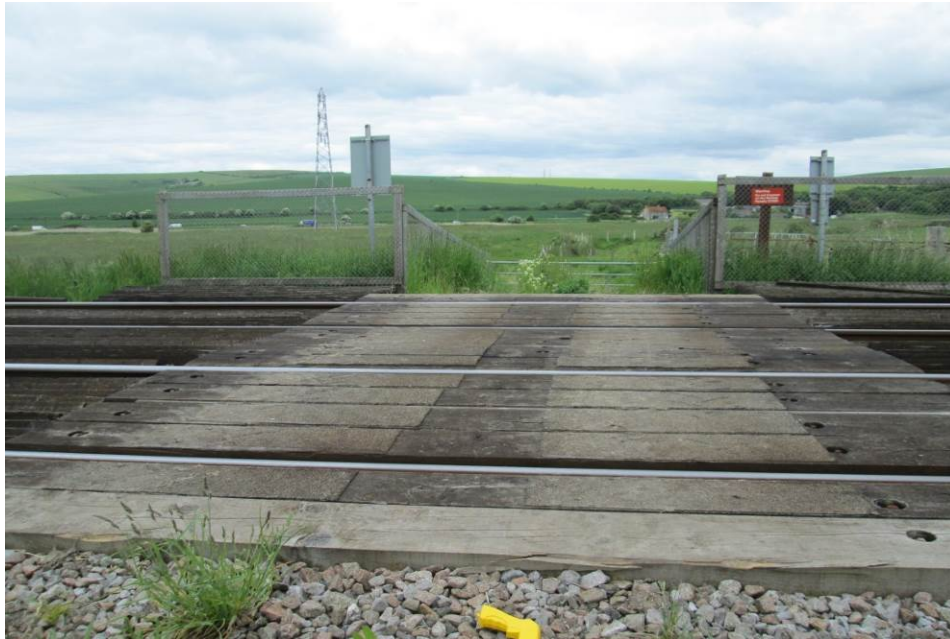
Up side looking across crossing

Trespass guarding is provided on both ends of the crossing at the required minimum distance of 2.6m which applies to all points on the crossing. The conductor rail is cut back further than the required minimum of 3m distance away from the crossing surface in both directions.

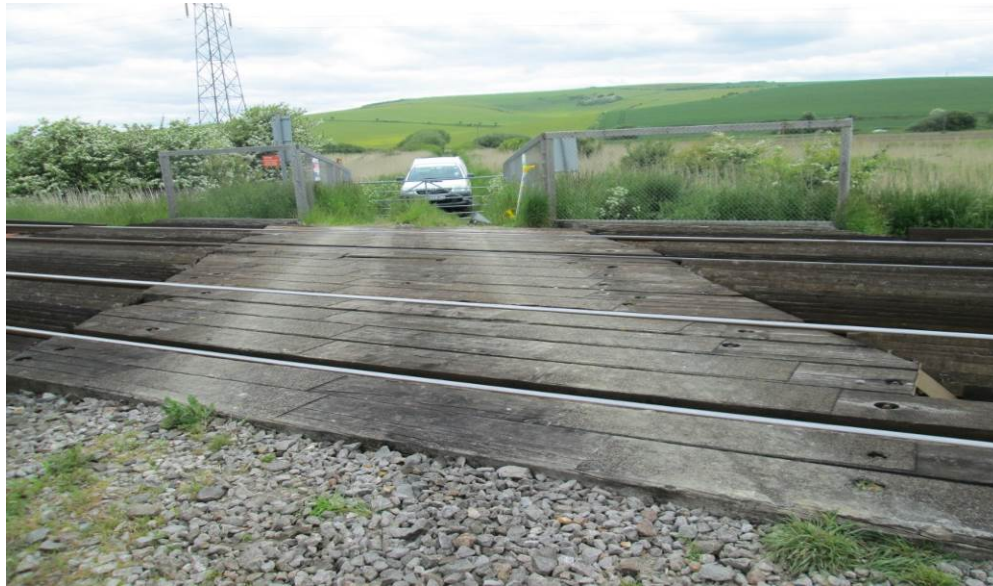
Upside looking across crossing

Trespass guarding is provided on both ends of the crossing at the required minimum distance of 2.6m which applies to all points on the crossing. The conductor rail is cut back further than the required minimum of 3m distance away from the crossing surface in both directions.

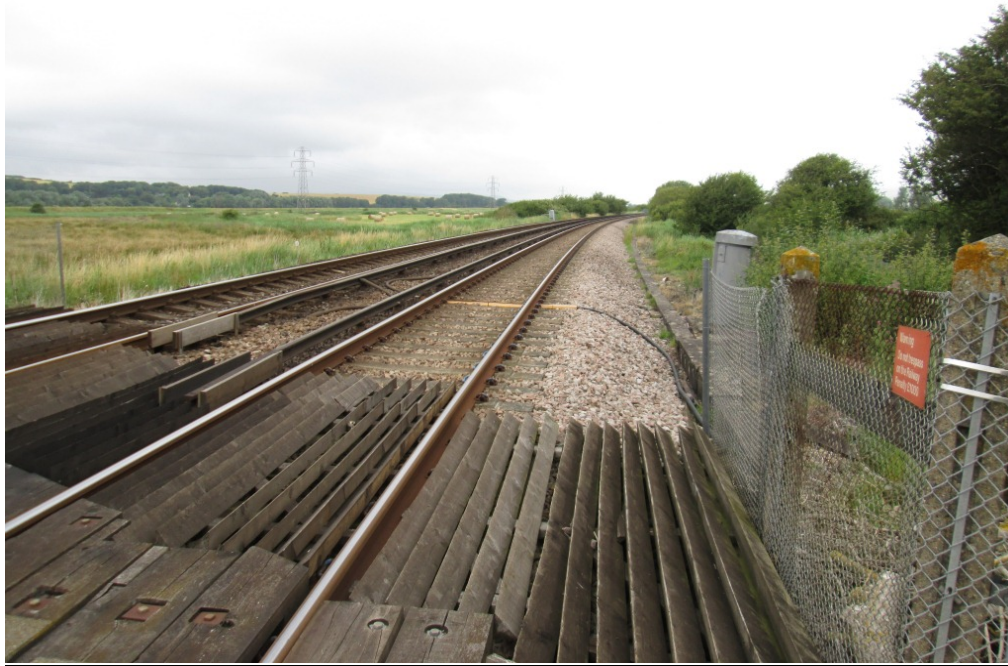
Stoor – down side down trains approaching view

The down side view is obstructed by the track curve and vegetation but a recent vegetation cut back enables a view of Durham Farm crossing from both sides now.

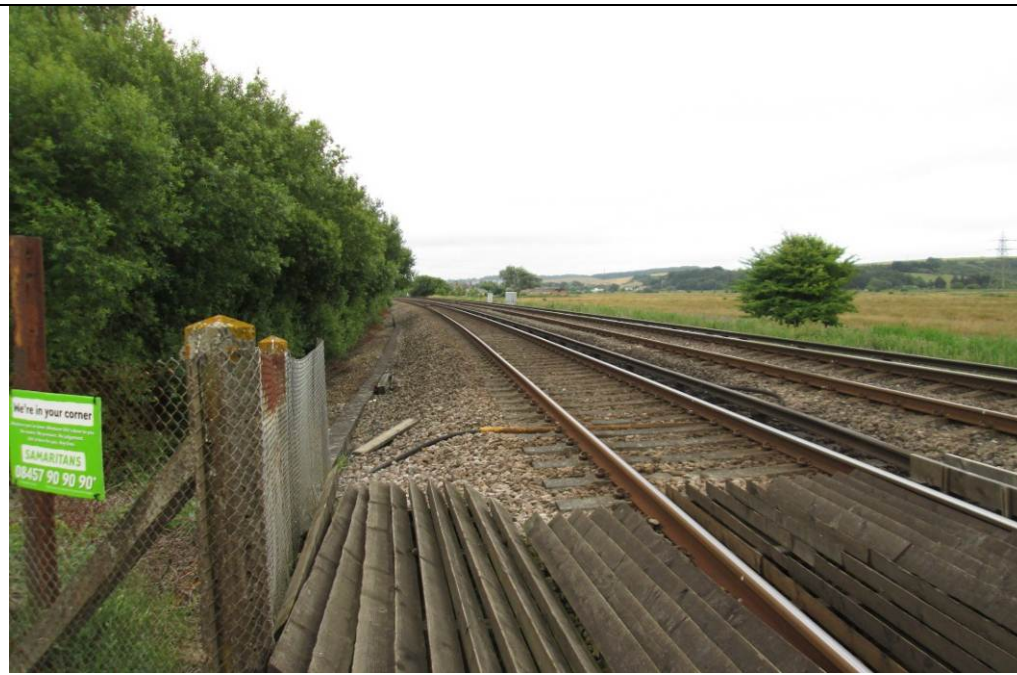
Stoor – down side up trains approaching view

Both approaches to the crossing surface, once inside the railway boundary are of a good quality underfoot and the crossing is protected by a chain link boundary fence line which encompasses both means of entry for vehicles and pedestrians.

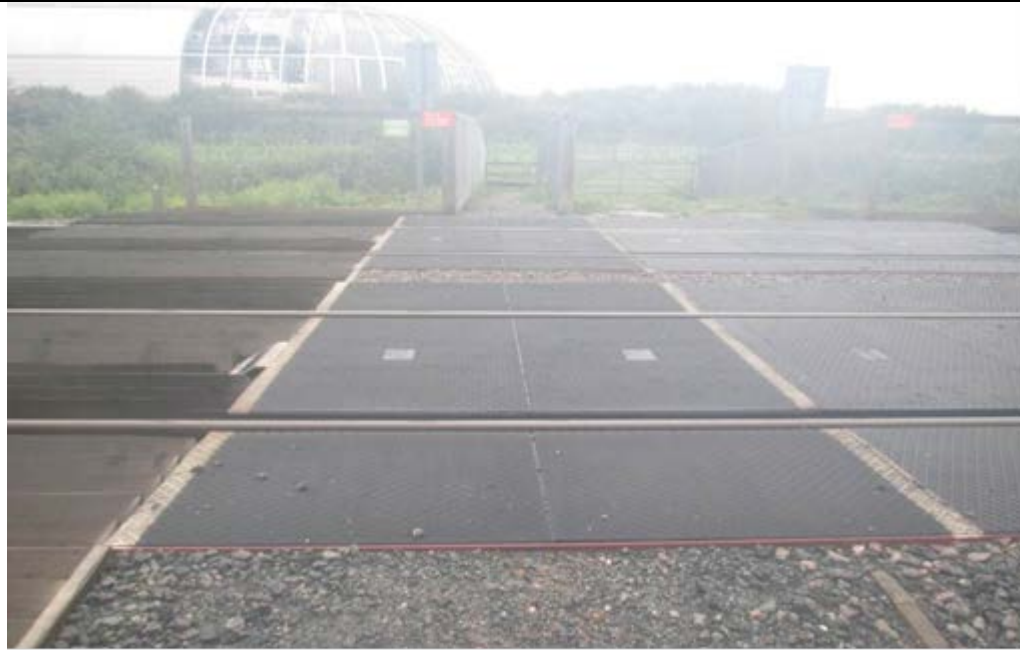
Inostrail and pedestrail view of crossing – down side looking across to the incinerator on the up side.

There are no telephones present and funding has been approved for the installation of these as sighting is deficient in all directions for vehicles therefore the crossing is currently non-compliant.

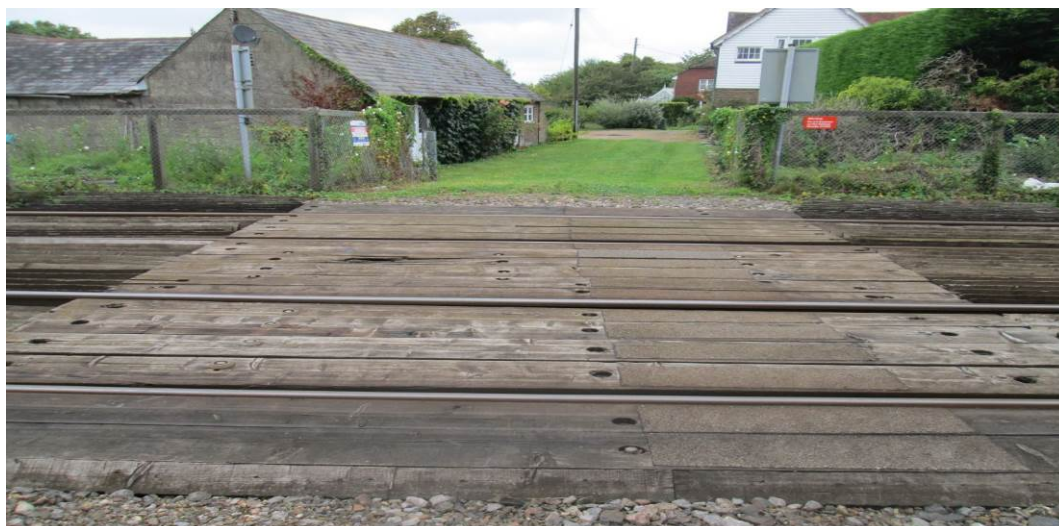
Up side looking across crossing

Vegetation grows lineside and during the warmer months may require more frequent cut back particularly on the up side looking up and down direction. There are MST's in place within the Ellipse system for these to be dealt with once a year. Anything else is dealt with reactively and picked up within inspection and risk assessment visits.

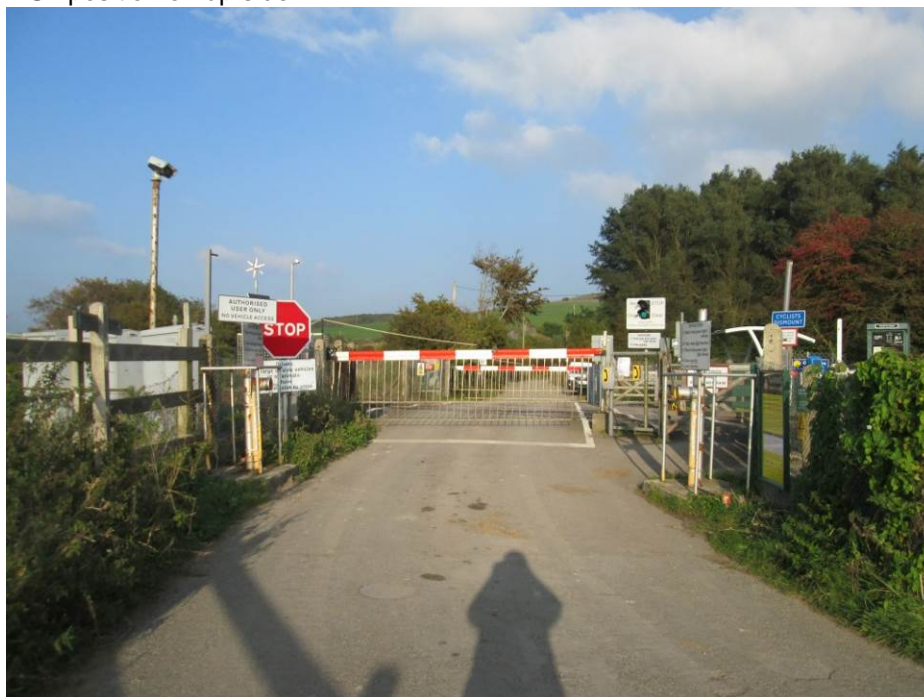
MSL position on up side

The signalling department has erected a temporary camera which overlooks the crossing as there have been some reports of wrong side failures in the last 2 years. This is where the strike out for the train is a short distance from the crossing in the up direction and the front of the 3 car train hits this as the last carriage is going over the crossing. This is to standard and fully compliant. These cameras do not produce good enough quality footage to use for misuse There is an option for the LC team to provide cameras at this location and a quote has been received and submitted for consideration.

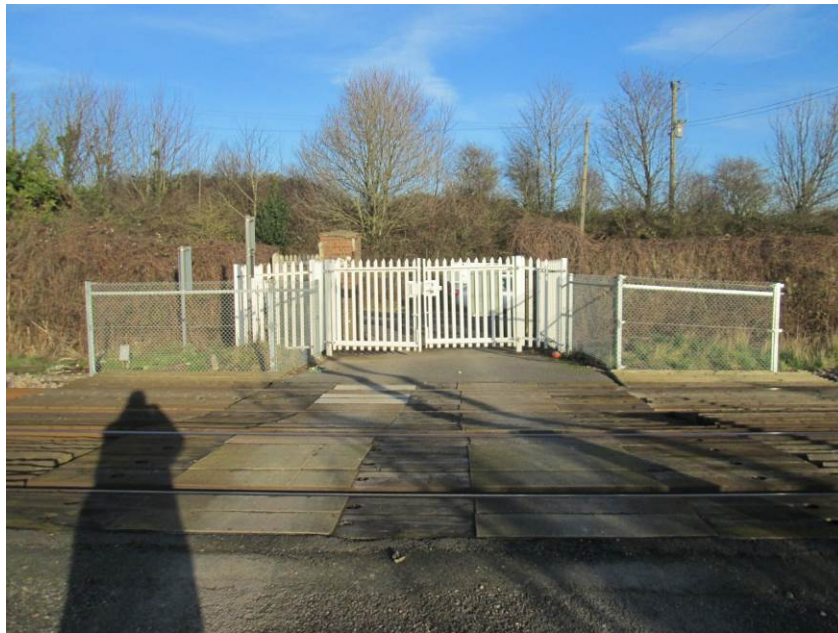
Up side across crossing

Trespass guarding is provided on both ends of the crossing at the required minimum distance of 2.6m which applies to all points on the crossing. The conductor rail is cut back significantly further than the required minimum of 3m distance away from the crossing surface in both directions.

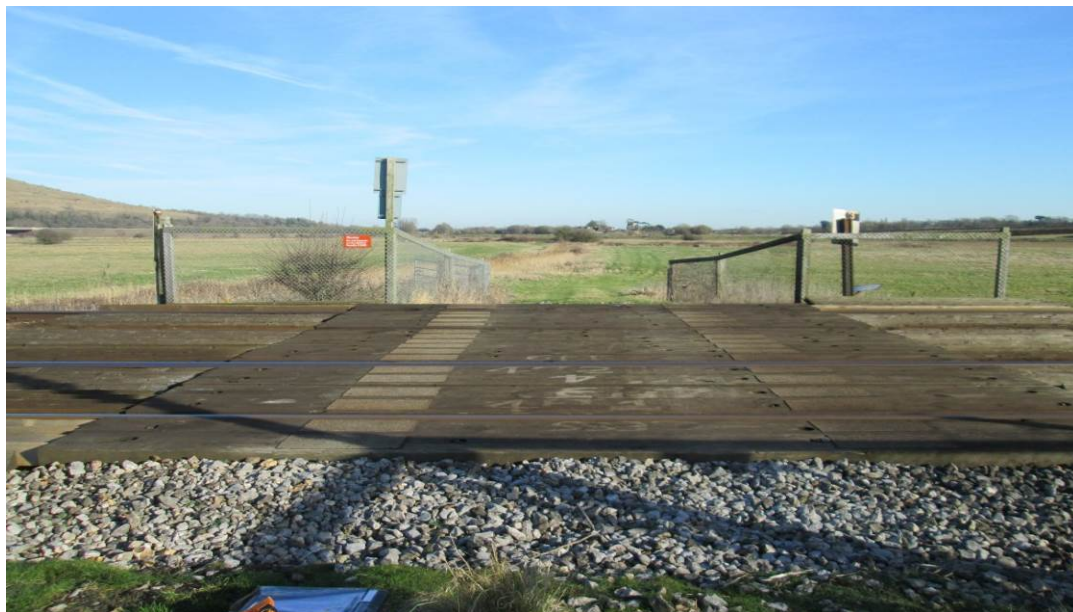
Up side across crossing view

Trespass guarding is provided on both ends of the crossing at the required minimum distance of 2.6m which applies to all points on the crossing. The conductor rail is cut back further than the required minimum of 3m distance away from the crossing surface in both directions.

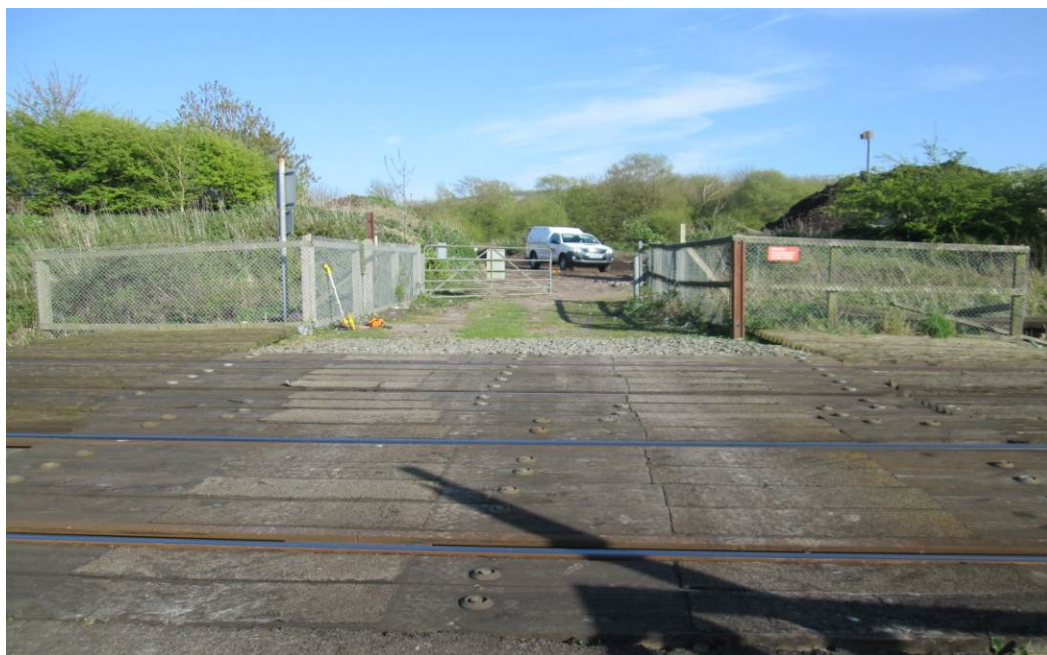
Up side looking across crossing

Trespass guarding is provided on both ends of the crossing at the required minimum distance of 2.6m which applies to all points on the crossing. The conductor rail is cut back further than the required minimum of 3m distance away from the crossing surface in both directions.
