London North Western (LNW) Route  
Level Crossing Risk Assessment

# **Bentley Heath**

## **Manually Controlled Barriers with CCTV**

14<sup>th</sup> December 2017

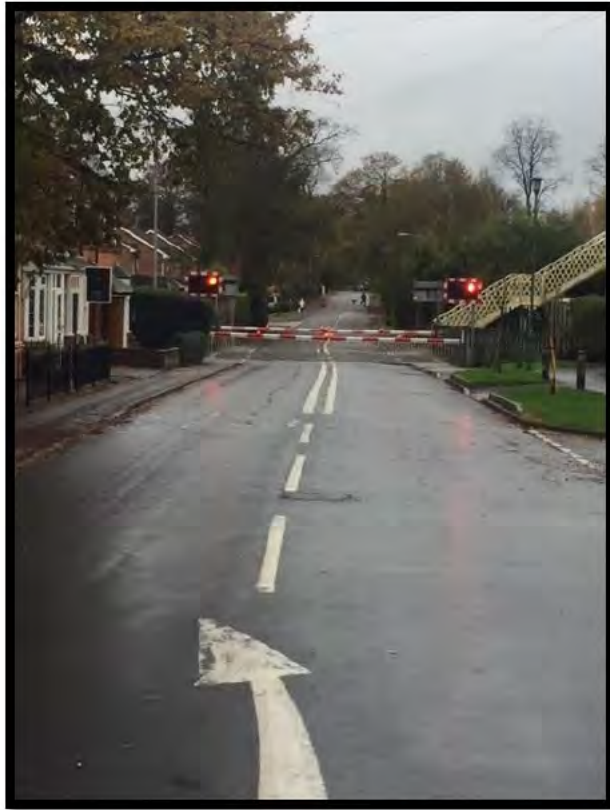
Up side approach to the Crossing

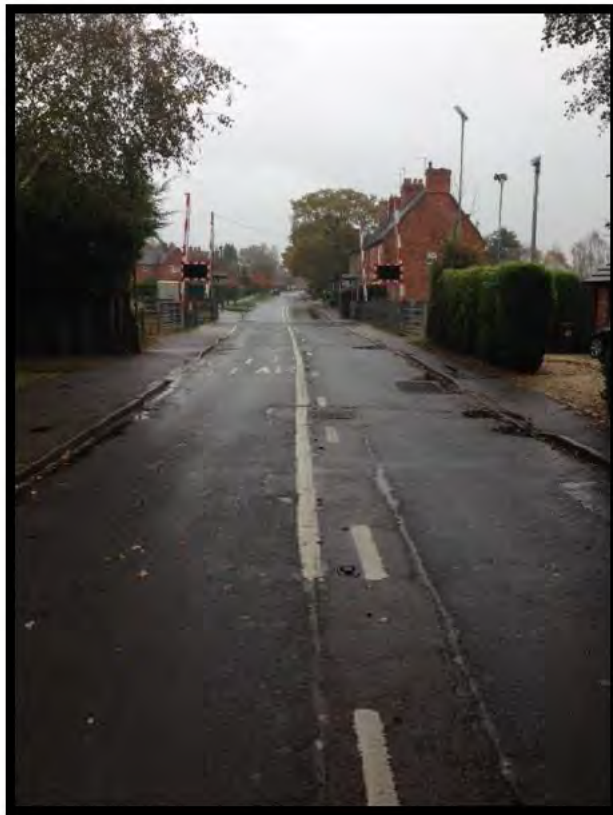
Down side approach to the Crossing

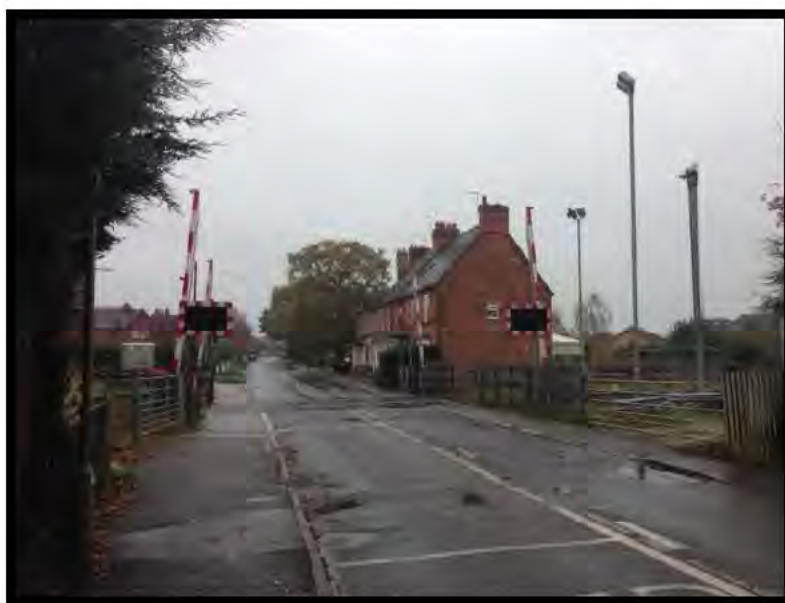
To note, a few metres away from the crossing on the West side are two access gates, one either side of the road, to railway infrastructure. Please see the table in section 3.2 for the correct mitigation if and when the access gates are required for use.

Access Gates on Either Side of the Crossing

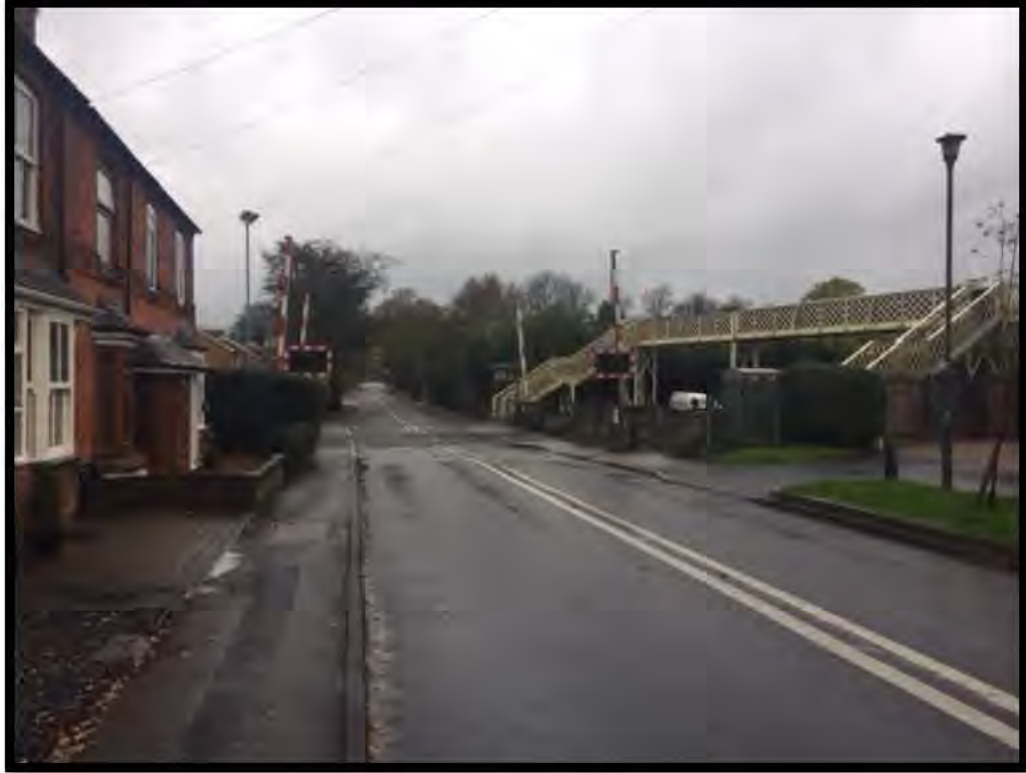
For pedestrian users it is important to note that there is a stepped footbridge located adjacent to the crossing with direct access on either side of the crossing from the approach footpaths. The bridge is well used when the barriers are lowered although mobility impaired users or users with pushchairs and cycles are unable to use it.

Footbridge at the Crossing

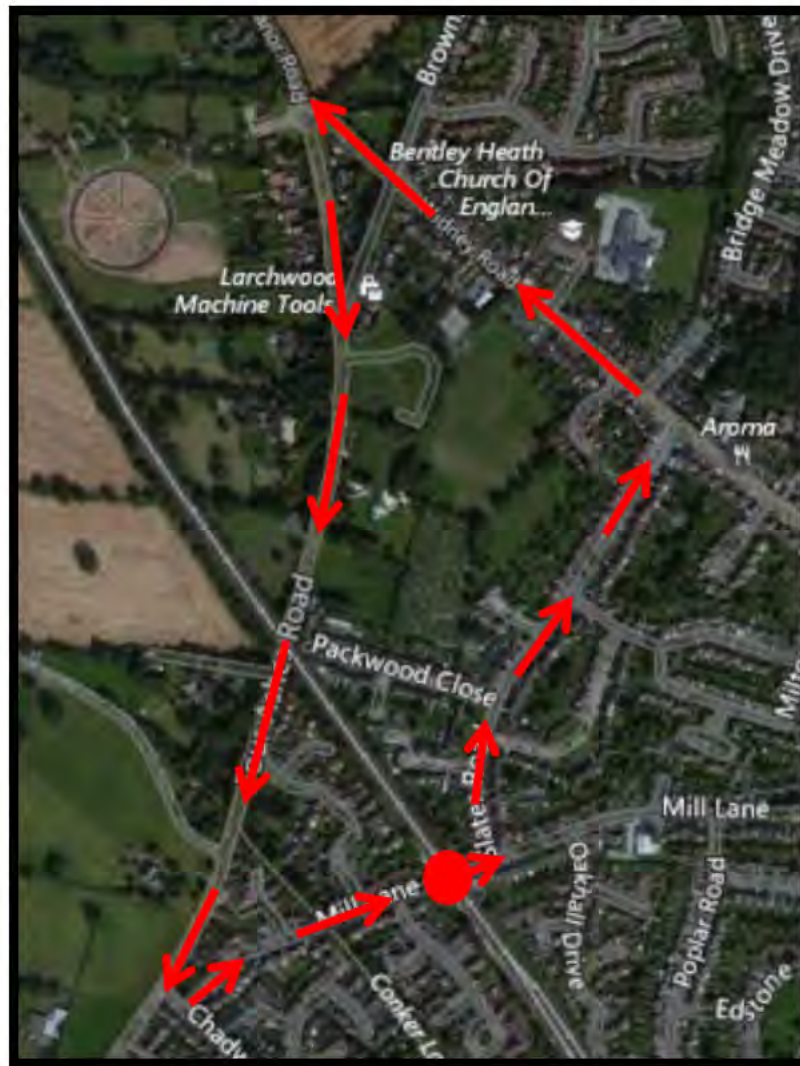
Map of Alternative Route

No work means that alternative routes exist and there is no need for Network Rail to create new paths or roads. At Bentley Heath, due to the surrounding area and the road layout a diversion with no work has been considered to close the crossing. This option would see the road crossing closed with the pedestrian footbridge at the site remaining in place for use. The maps below show that alternative routes for users are available and would be approximately 1.5 miles long, which in a car is only a few minutes extra. Many locals in the area avoid the crossing already when the barriers are down and use the alternative routes along Mill Lane/Slater Road/Four Ashes Road/Earlswood Road and Widney Road to get to the local amenities at Dorridge or out of the village. One down side to this option would be that mobility impaired users of the crossing would have to negotiate the stepped footbridge. At this time, although it would most likely meet with local opposition, this option should be considered.
