Farnborough North Level Crossing Narrative Risk Assessment

September 2021

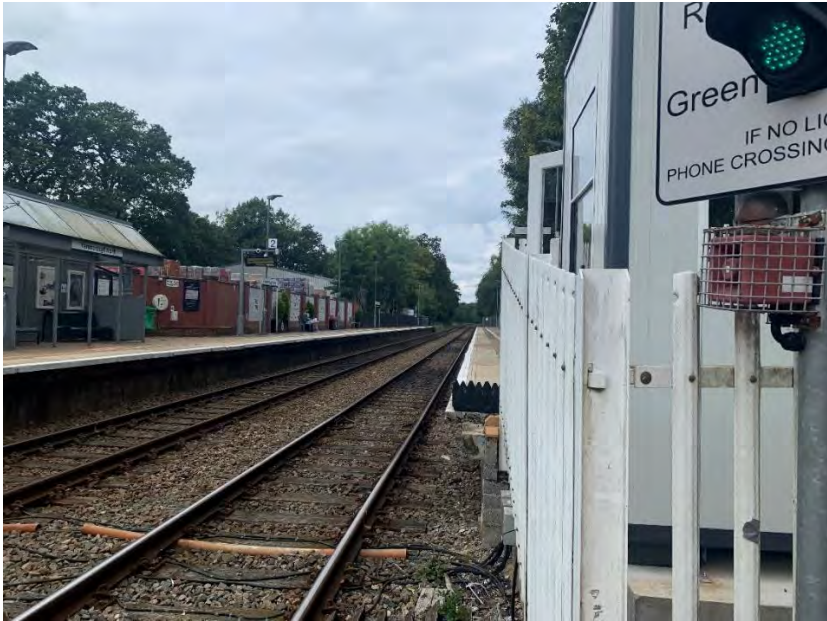
- 2.7.8 Upside, Up direction train approach at 1.2m Decision Point

- 2.7.4 The 'Up' side (Frimley side) decision points, looking in both directions, is obscured at 2m by either the crossing attendants hut or the house. This forces a user to enter the 'danger zone' and move to a point of danger approximately 1.2m from the running rail in order to achieve clearer sighting.

Required Minimum Sighting for 12.62s traverse time	Ideal Sighting Distance	Measured Sighting	Actual Warning time	Measured from crossing to?
Upside looking towards Up direction train approach	395m	489m	489m	15.62 s	Vegetation on upside curvature
Upside looking towards Down direction train approach	395m	489m	366m	11.71s	Vegetation on upside curvature
Downside looking towards Up direction train approach	395m	489m	437m	13.97s	Vegetation on upside curvature
Downside looking towards Down direction train approach	395m	489m	309m	9.87s	Vegetation on upside curvature

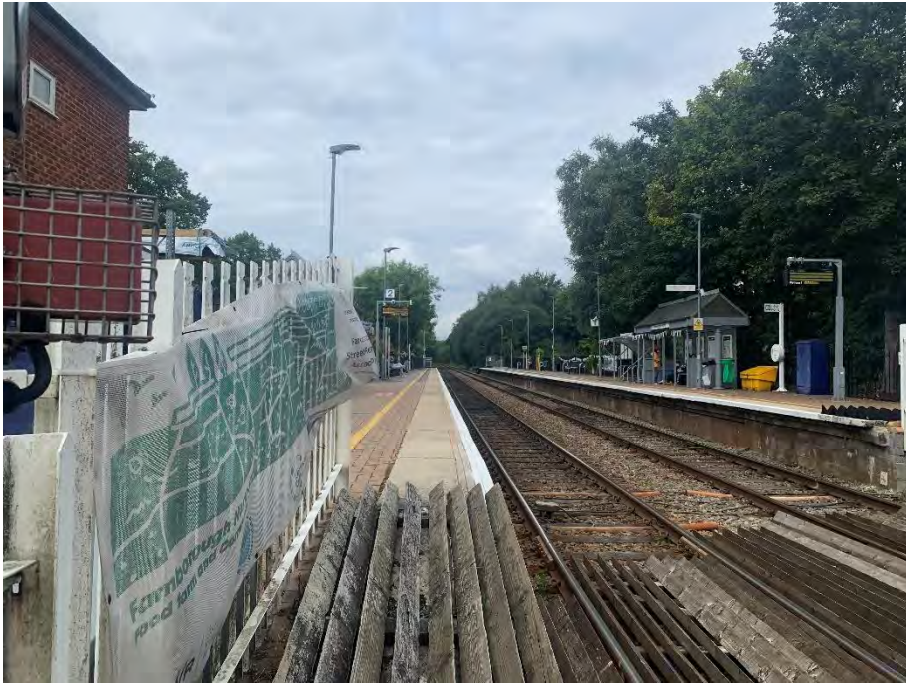
2.7.10 Downside, Up direction train approach at 1.5m decision point

- 2.7.5 The 'Down' side decision points, looking in both directions, is obscured at 2m by MSL equipment and fencing. This forces a user to enter the 'danger zone' and move to approximately 1.5m from the running rail in order to achieve clearer sighting.

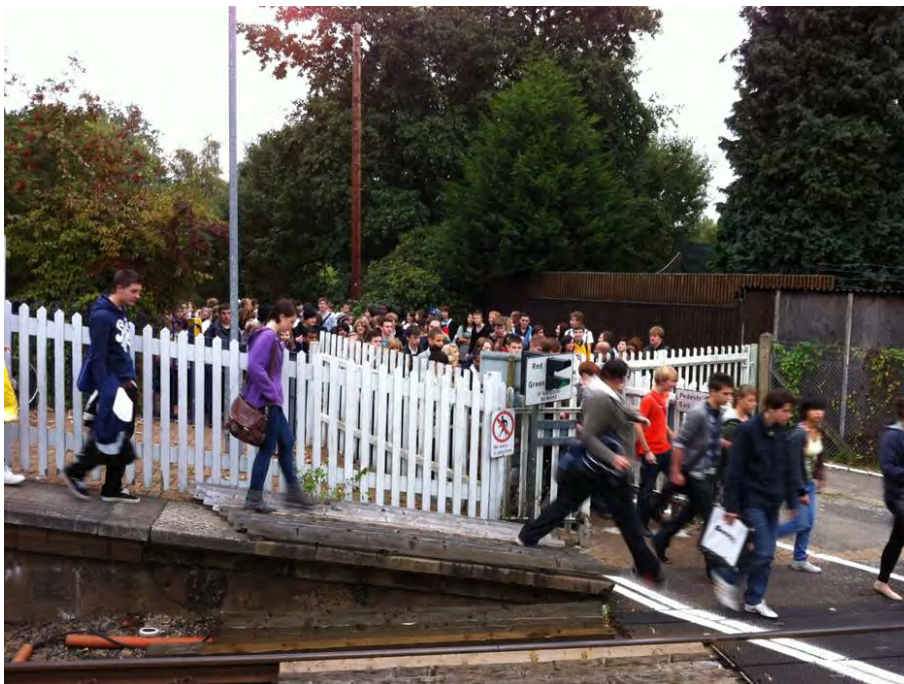
2.8.11 The picture below shows the set-up prior to the introduction of the attendants. It highlights not only the high number of people wishing to cross, but also of the behaviours that were common practice to gain access over the crossing, on exiting the station by passing over the trespass guards.

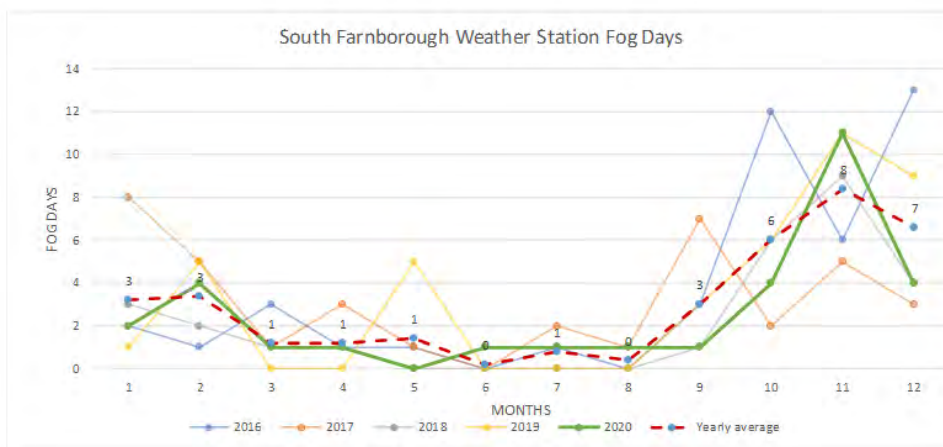
South Farnborough Weather Station Fog Days

2.14.5 Below is a graph from the nearest weather station (South Farnborough) to the Crossing highlighting recorded fog conditions at the crossing for the last 5-years.

2.14.6 The data shows that during the colder months of the year Farnborough North is more susceptible to fog days. It has been noted by the LCM that cold days with little to no wind can result in the area suffering from fog that can last for several hours, with particular build-ups in the morning hours.

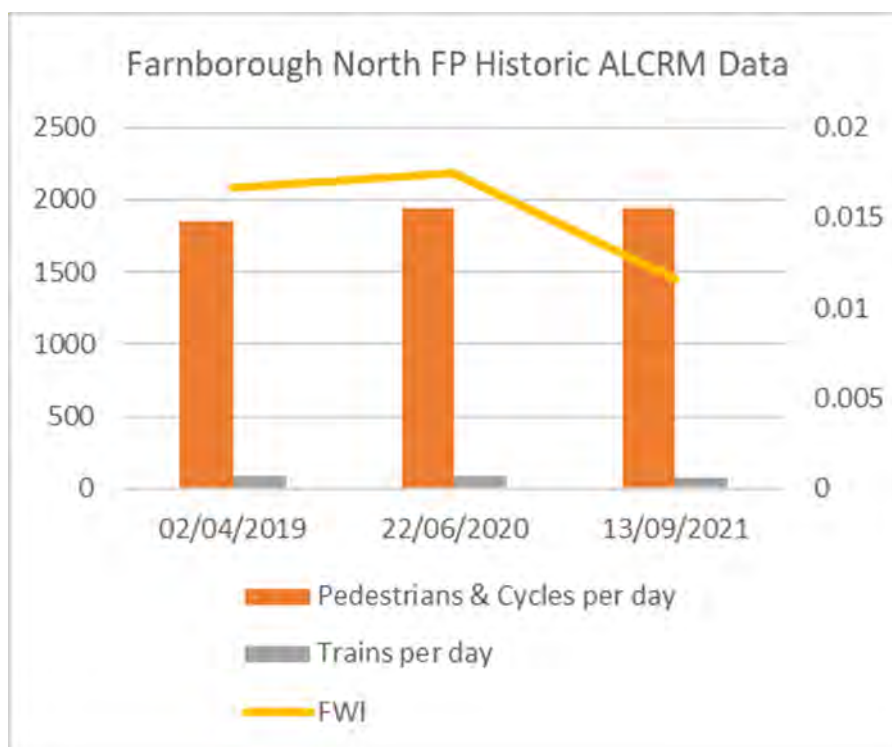
3.11 The historic ALCRM data below shows a slight increase in FWI between 2019 and 2020 which is attributable to increases in pedestrian & cycle users per day. There is a steep decrease between 2020 and 2021 which is attributable to the ALCRM algorithms more accurately reflecting risks at crossings.

3.12 Another contributory factor to the decrease in risk is the change in the way the risk model, ALCRM, assigns risk. The changes made have aligned the risk modelling more closely with the Safety Risk Model produced and updated by the Rail Standards and Safety Board (RSSB). The change saw the risk profile change crossing risk scores both up and down, with most footpath crossings increasing their risk score while protected road crossings reduced their risk score. This change took place in April 2021.

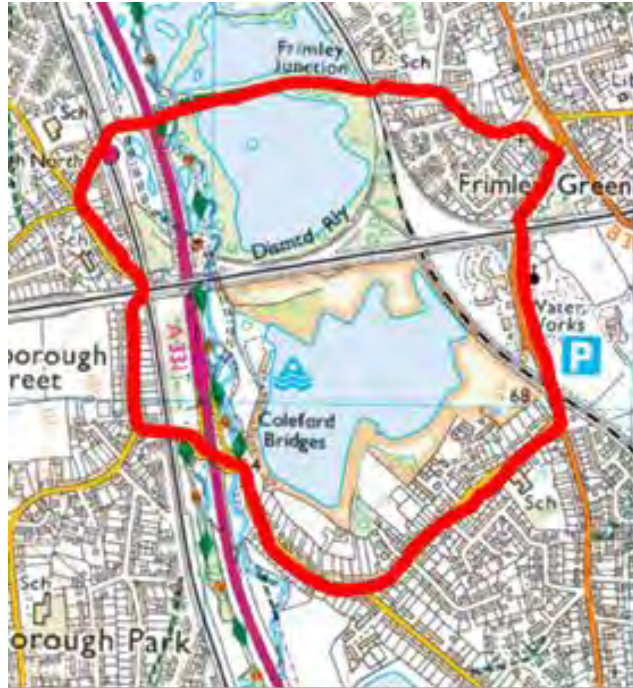
- 4.4.5 The diversionary route highlighted in red below is 2.4 miles.

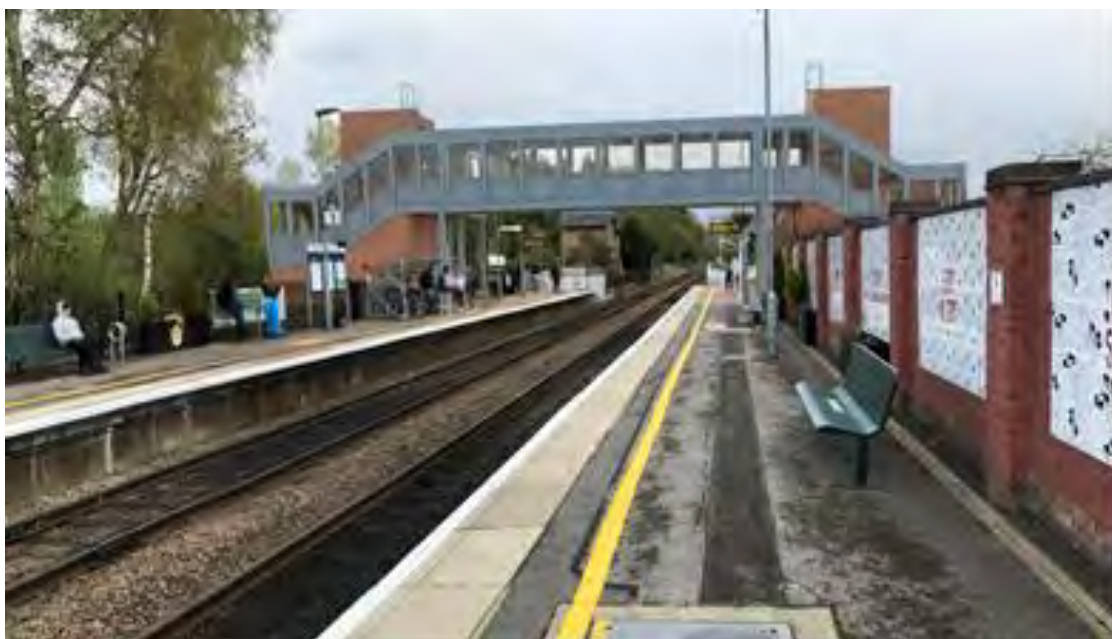
- 4.7.5 This option removes all risk at the Crossing.
- 4.7.6 Applying the Gross Disproportionality Factor, there is a business case for this option.
- 4.7.7 The following two diagrams give an indication of the expected stepped and lift structure that would be implemented as part of this proposal.

- 4.7.1 This option has been recommended. A stepped bridge, with lifts built in accordance with British Standards will fulfil Network Rail’s PSED to those with protected characteristics, and will also fulfil the station requirement for assisted travel. It is proposed an accessible bridge with lifts can be built to the north of the current crossing as part of the station platform area.

- 4.7.3 The risks at the Crossing will be completely removed while allowing the large vulnerable population safe passage.
- 4.7.4 This option is reliant on the purchase of third-party land for a path to be constructed, linking back to the existing paths on either side of the Crossing.
