**South West Rail Resilience  
Programme: Colonnade to  
Coastguards**

**Option Selection Report**

142630-ARP-REP-EMG-000023

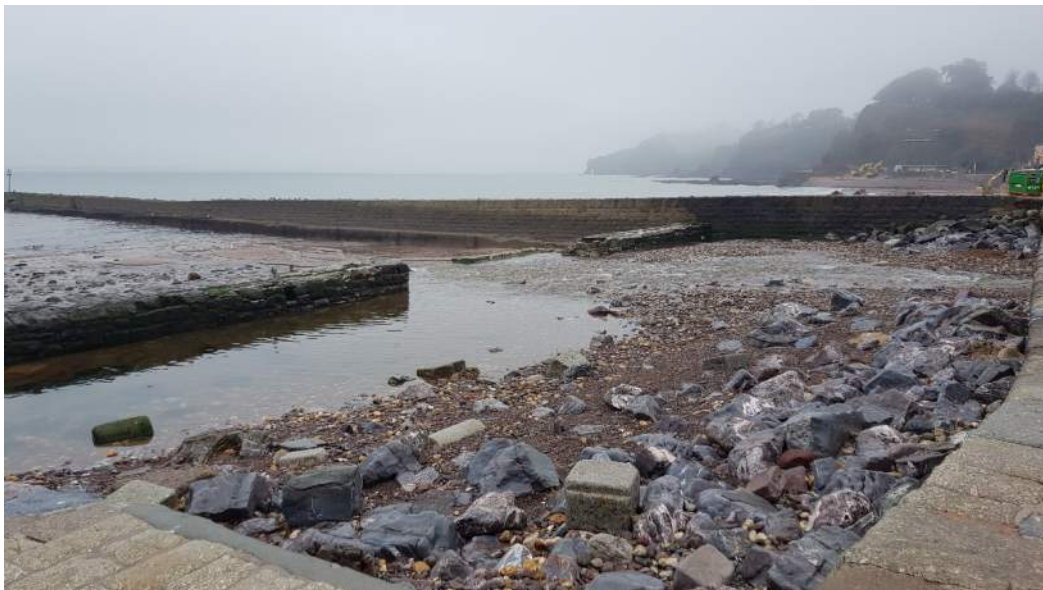
Figure 2 - Dawlish Water basin interior

Dawlish Water runs through the town and reaches the sea at the south-western end of the site. It discharges through the Dawlish Water Basin, a build-up of sediment contained by concrete walls.

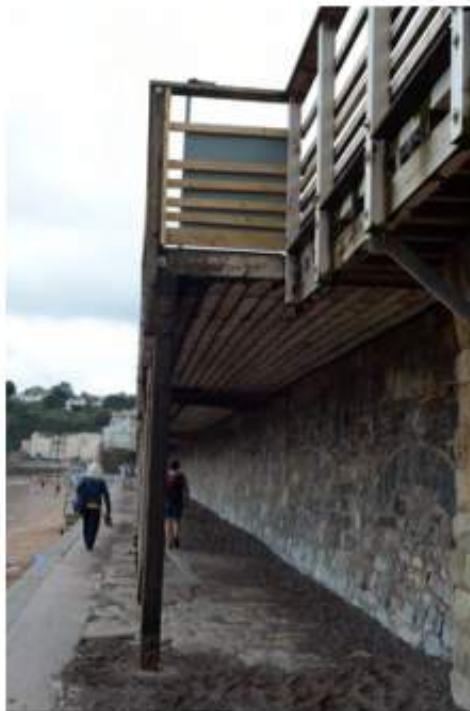
Figure 8 - Section D1 platform overhangSea Wall (Section D2)

The existing sea wall that extends from the down platform station building to the end of the wider portion of platform 1 sits to the rear of the promenade, and is topped with the overhanging platform structure, as illustrated in Figure 7 and Figure 8. The overhanging timber structure is supported by evenly spaced timber columns, and the soffit of the structure is formed of timber planks, containing the platform structure. Drainage ducts run through the wall from both the above and below track areas. It has been noted from site visits that some of these ducts are occupied by nesting pigeons.

1. Section geometries are based on the topographical survey. Wall section thicknesses are based on Sections W6 and W7 of the Structural Investigation Report which are conservative interpretations of "Section D" in the Feasibility Comparison Report (142630-ARP-REP-ECV-000022).

Variable dimensions are clouded

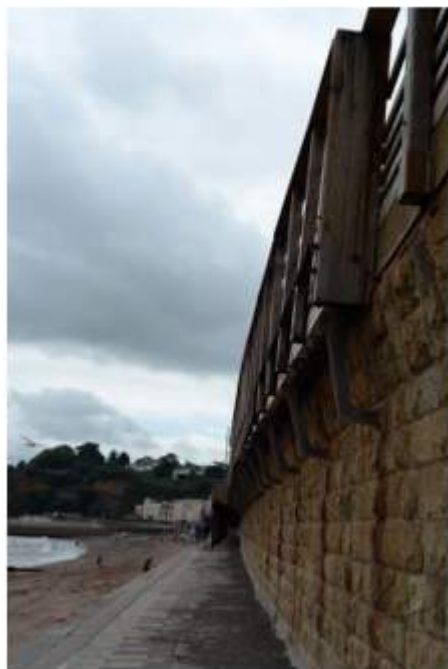
Beyond the narrowing of platform 1 the sea wall takes on a modified typical section, this time with the platform cantilevering from the top of the sea wall without additional propping support from the promenade. Typical section is shown in Figure 9. The overhang of the platform varies, starting at around 700mm reducing towards the north to a point where the railing is affixed directly to the top of the wall and there is no overhanging extension, see Figure 10 below which shows this transition to the railing being attached to the top of the wall.

1. Section geometries are based on the topographical survey. Wall section thicknesses are based on Sections W6 and W7 of the Structural Investigation Report which are conservative interpretations of "Section D" in the Feasibility Comparison Report (142630-ARP-REP-ECV-000022).

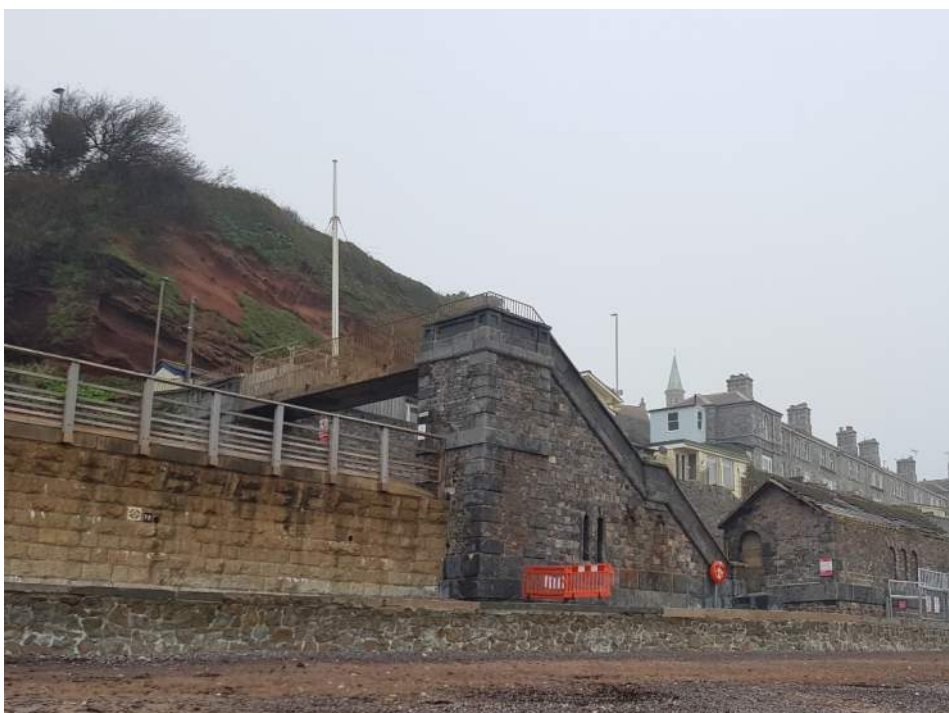
Figure 11 - Coastguards footbridge

The Coastguard's footbridge is a post tension concrete deck dating back to the early 1950's and is situated towards the north eastern end of the site. This is not a listed structure but does form part of the Brunel heritage railway, and the granite structure of the stairs (along with the adjacent Coastguard's Boathouse) form the surviving elements from the early years of the line. The stairs are not a modern structure and are not compliant with modern standards. It appears that the bridge deck has been replaced with a precast concrete deck which is newer than the stairs. The bridge appears to be in a reasonably good condition, particularly considering the aggressive environment in which it is located.

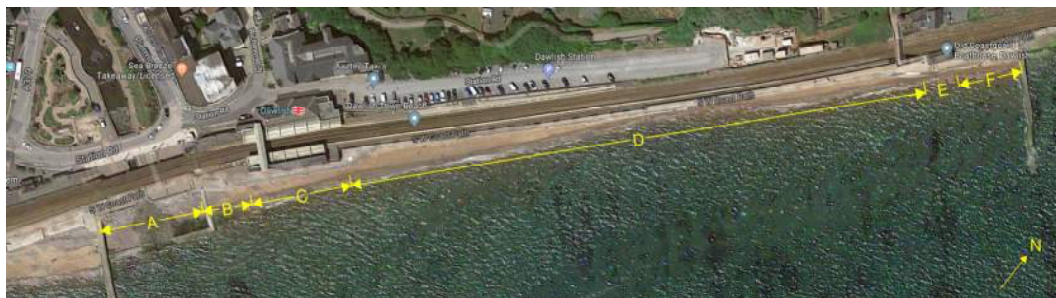
Figure 12 - Aerial view of C2C sections

For the optioneering stage of the scheme, the site has been split into sections A-F as per Figure 12. The track is mostly level along the length of the station, around ~6.4m AOD. This is mainly due to the set level of the viaduct to the south of the station. To the north-east of the station is the lowest area (the start of section D) at ~6.2m AOD and is approximately 80m long (206m 4ch to 206m 8ch), and therefore this is most susceptible to flooding. Beyond this the level rises to ~6.5m AOD at the far north-east (end of section D as well as sections E & F).

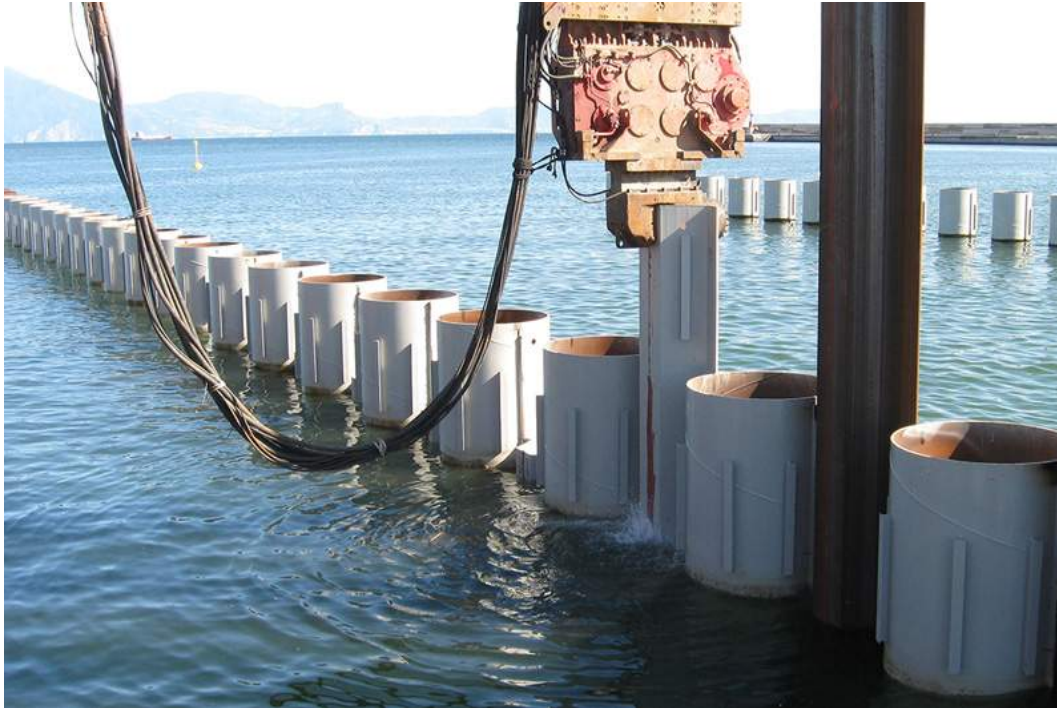
Figure 19 - Combi wall example

This option involves driving circular hollow steel tubes down to the level of rockhead as a permanent casing. The material within the tube is then augered out and the bore is continued into the rock below the base of the casing to the level required for design. A cage is lowered into the augered section of the pile to provide reinforcement and the pile is concreted to top of casing. U or Z section sheet piles are then vibrated/driven between the adjacent piles to the rock level. Mobilisation of significant pile driving equipment is likely to be unfeasible from both a temporary works perspective and the need to avoid damage to the existing seawalls during driving. Embedment of the sheets into the bedrock is therefore likely to be minimal.

This option was discounted due to its inability to provide scour protection at the locations of the interconnecting U or Z sections over the design life of the structure.

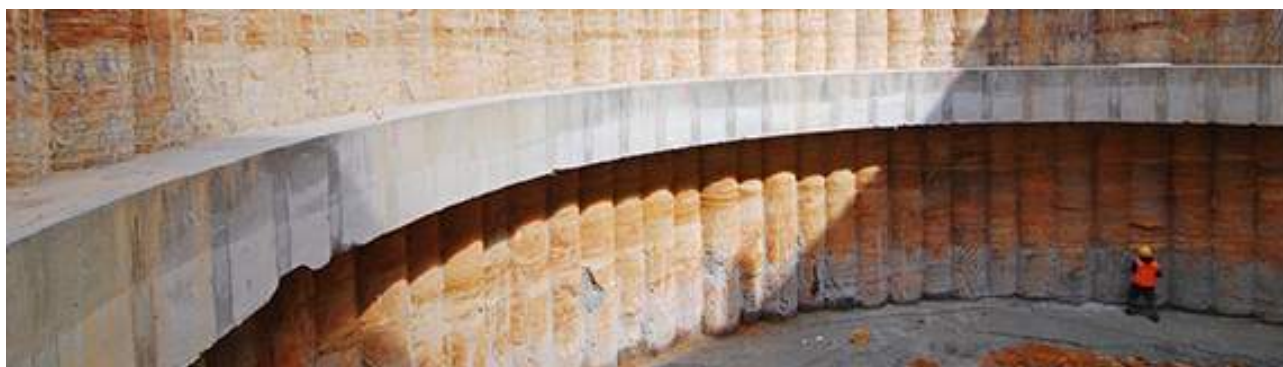
Figure 21 - Secant piled wall

This option involves a continuous row of overlapping piles used to form the wall structure. Circular hollow steel tubes would be utilised as casing down to rock level to stop loss of concrete through beach deposits (controlling the environmental hazard), with alternate reinforced “male” piles.

This option was discounted due to the requirement to case. Overlapping casing will not be possible because the casing is likely to need to be sacrificial to prevent loss of concrete into the sea. The concrete within the unreinforced female piles is also unlikely to be able to withstand the marine loading.
