Western

Route CP6 Weather Resilience and Climate Change Adaptation Plans

Western Route Weather Resilience and Climate Change Adaptation Plan – Version 1 – September 2020.

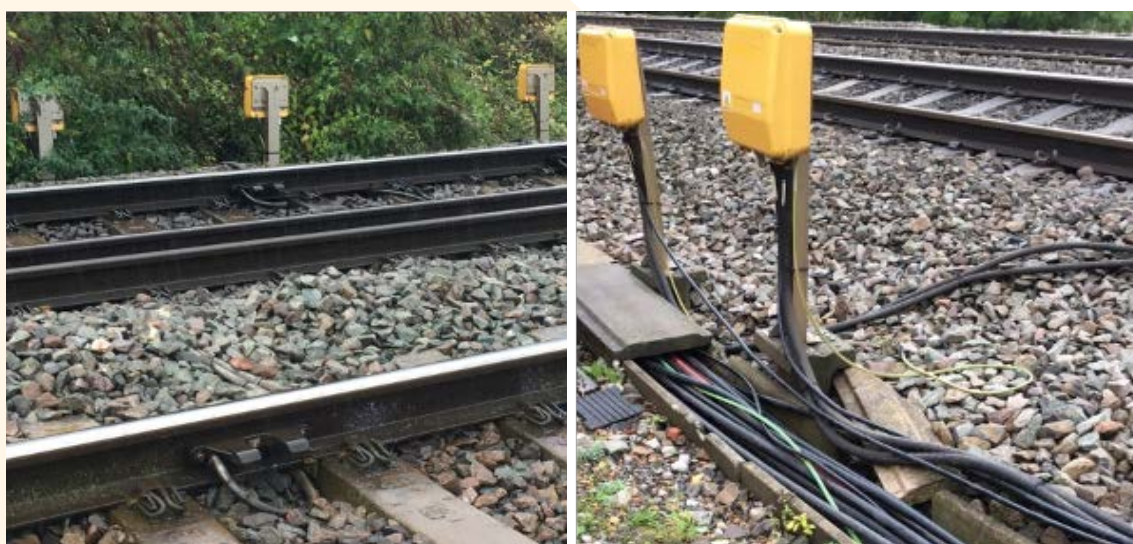
Figure 20

however, 34% of points related failures were classified 'No Cause Found'. Overheating Cyclon cell batteries were responsible for one major failure at Bristol East Junction, and three other points failures, making this the highest attributed failure mode for points failures. Train detection also experienced a number of failures at high temperatures above 21°C – although it should be noted that there are a number of other issues that may have contributed to the axel counter failures.

Scrap rail left within 2m of heads (left) and poor installation of axel counter (right)

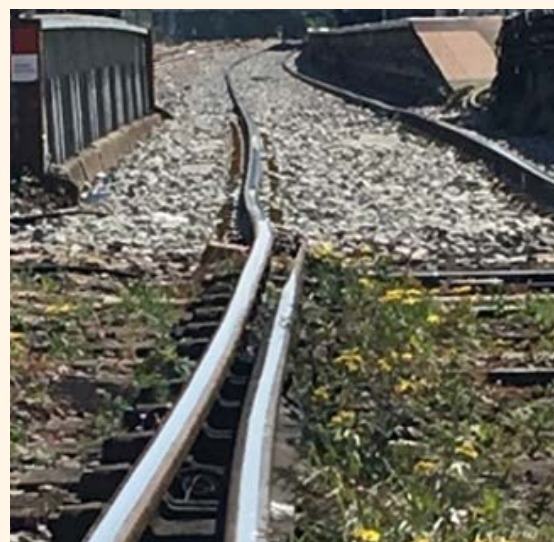
The track itself is vulnerable to high temperatures as compressive forces which develop in rails expanding in hot weather can cause the rail to buckle, resulting in a short but severe misalignment. The incident shown in Figure 21 at Oxford resulted in emergency works being required and associated train delays.

Track buckle at Oxford, May 2018

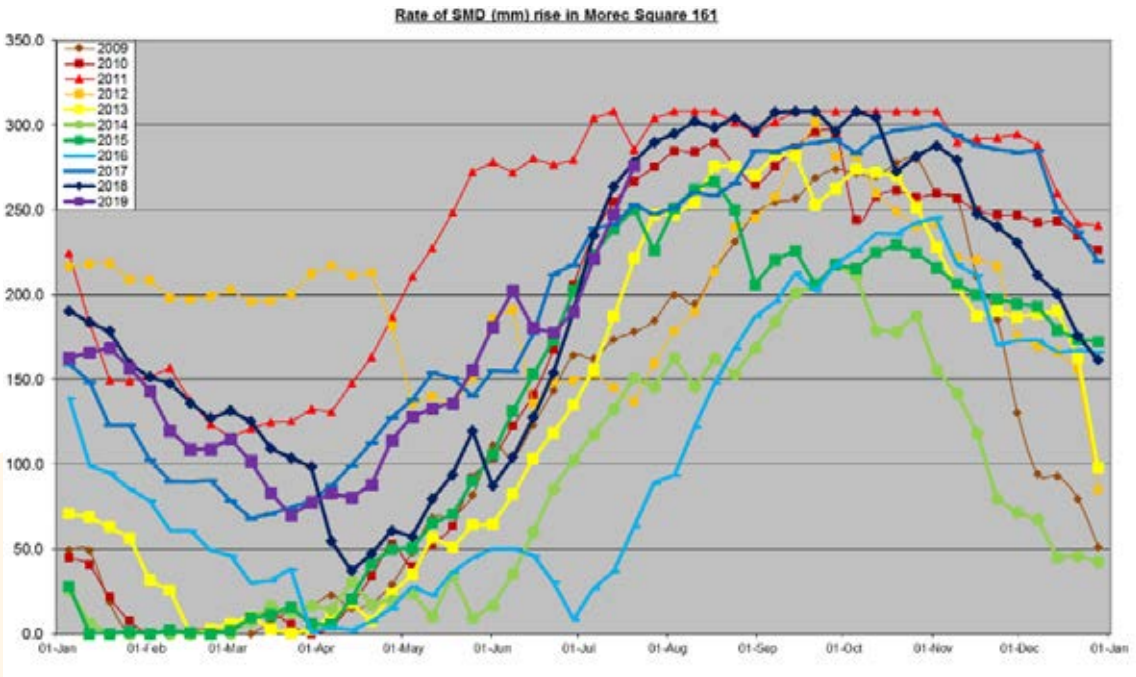
This was exacerbated by the dry and hot summer following a wet winter causing a significant differentiation in SMD from winter to summer.

Figure 22
Example of SMD tracking, updated weekly for TSR board

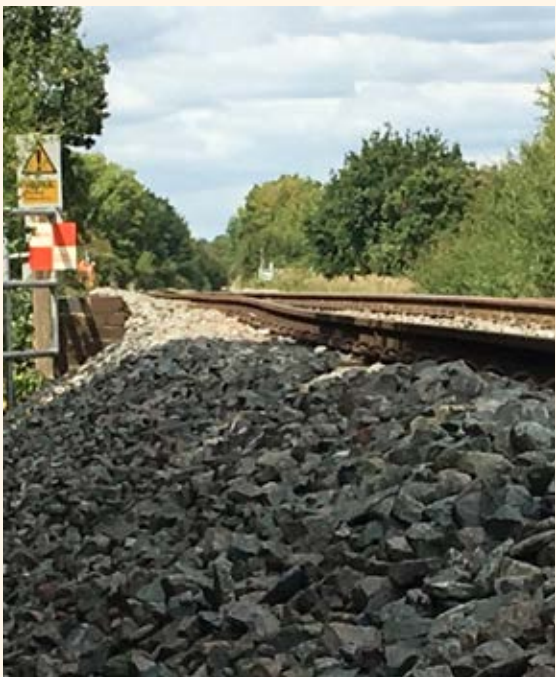
Figure 23
Image showing track alignment issues when transitioning to underbridge

Shrinkage in the embankment and subsequent movement of the track above led to a number of track alignment issues, especially on transition to underbridges and other underlying hardstandings. The track issues were exacerbated further by the very low levels of track maintenance undertaken due to the exceptionally high track temperatures and the risk of track buckling if disturbed – a total of 10 no. Temporary Speed Restrictions (TSRs) were imposed due to underlying desiccation issues.

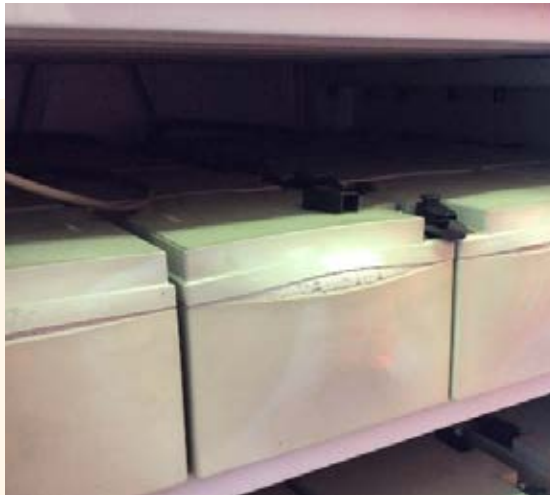
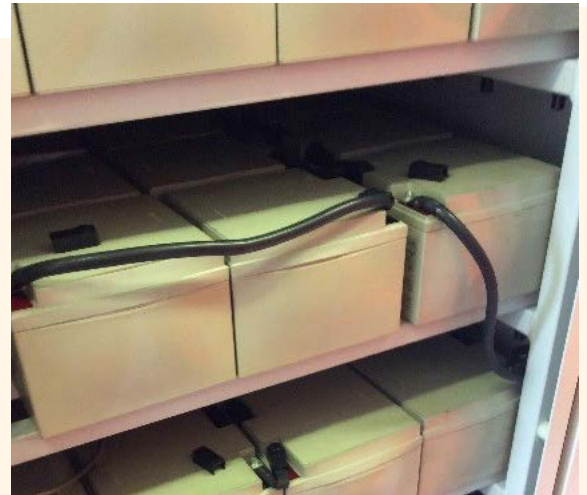
Figure 24

During hot weather in August 2015 all Signaling was lost in the Southall area due to a power failure. The train service in and out of Paddington station was severely affected with over 8000 minutes delay attributed to the event. The UPS at Southall had overheated and shutdown.

The overheating was due to a complete failure of the air conditioning in the equipment room and technicians attending the fault stated the room was initially too hot to enter. The UPS batteries expanded in the excessive heat and all had to be scrapped. This incident prompted a change in cooling philosophy in UPS rooms and new installations are now cooled by forced air cooling which is more reliable than air conditioning.

Overheated batteries, Southall UPS, August 2015

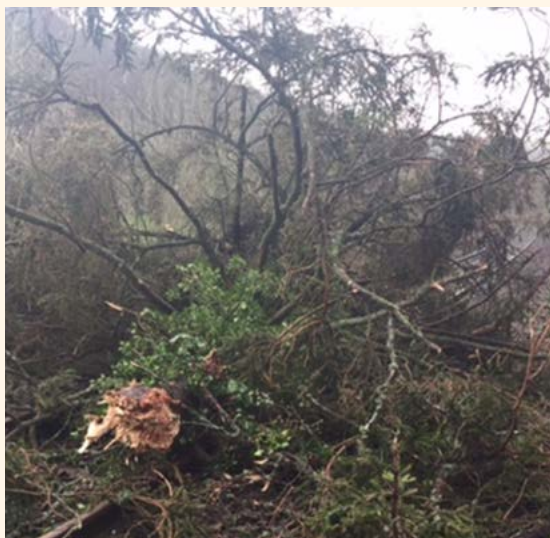
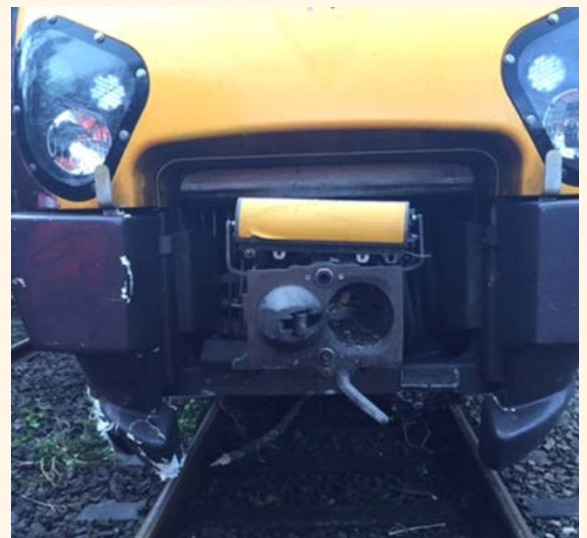
Figure 25

A number of storms have hit the Route during CP5, the most damaging of which occurred in 2016 – notably, Storm Katie (March 2016), Storm Imogen (Feb 2016) and Storm Angus (Nov 2016). All caused significant damage to infrastructure and train delays due to issues such as flooding, washouts and fallen trees.

Fallen tree at Bodmin and damage to Voyager

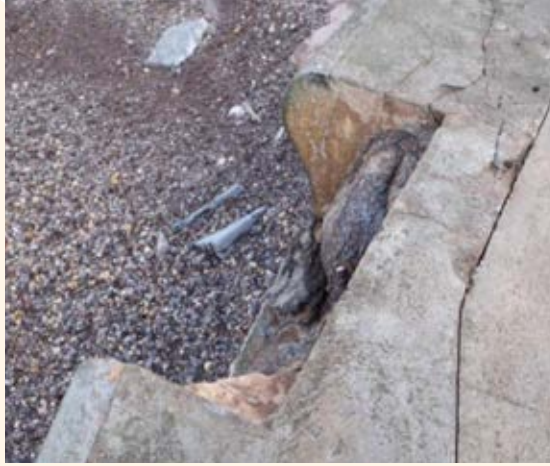
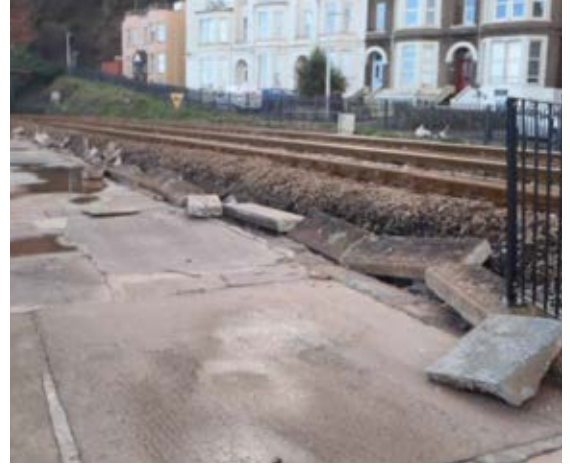
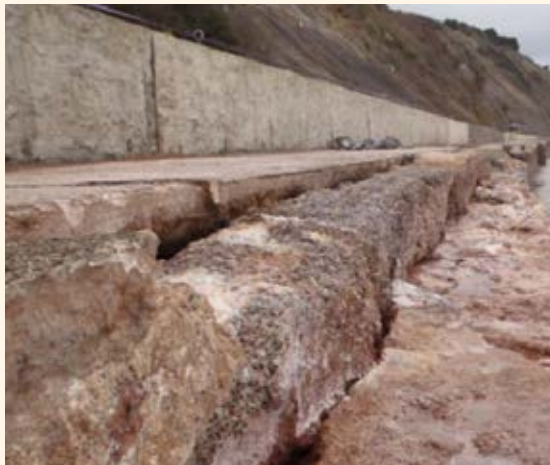
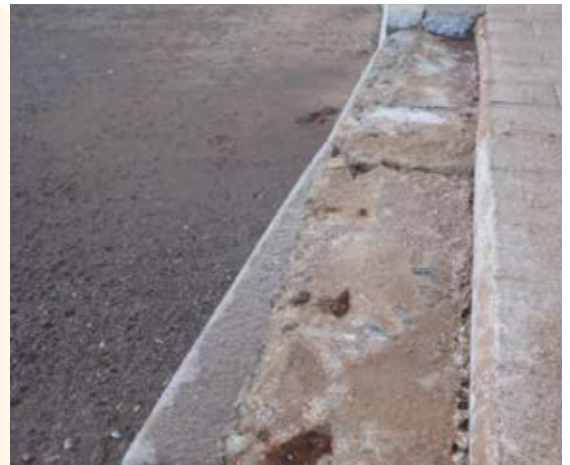
Figure 26

Storm Emma and other unnamed storms in the winter of 2018 caused damage to the Dawlish Wall. The damage was mainly damage to the walkway, missing and dislodged copings and the

loss of fencing adjacent to King Harry's Walk. There were no major defects to the fabric of the wall through CP5.

Image showing effects from storms at Dawlish during the winter of 2018

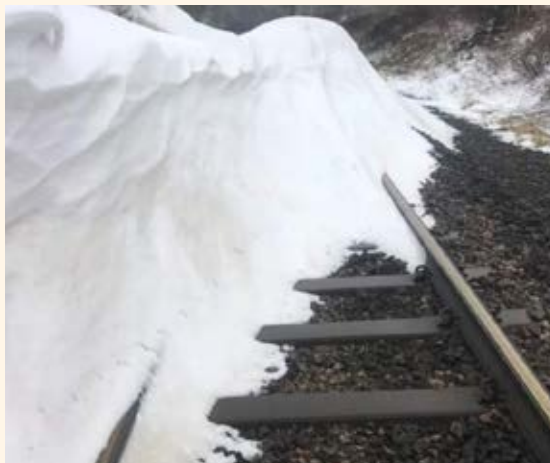
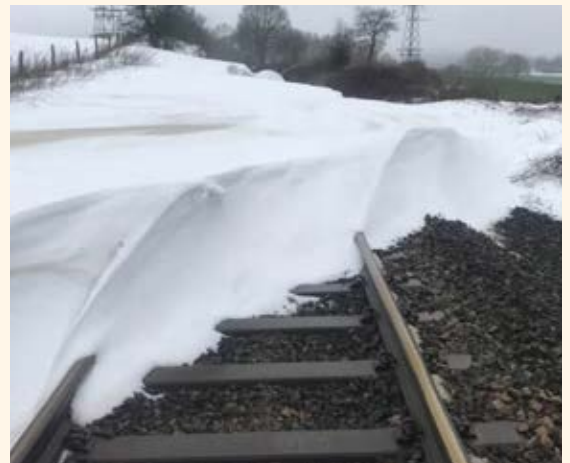
Figure 27

In the winter of 2018, severe snow and cold hit Western Route in addition to the majority of the UK – this storm was known as the ‘Beast from the East’. The storm caused significant disruption due to the snow drifts on the line and closure of railway platforms.

The deep snow covered the rail head stopping the Train Operating Companies (TOCs) and Freight Operating Companies (FOCs) running their fleet until snow ploughs could be deployed to clear the paths and to enable the safe running of the railway.

Snow fall covering the rails during the ‘Beast from the East’ (2018)

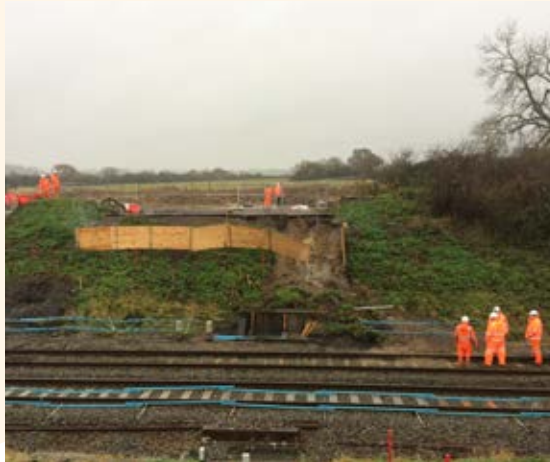
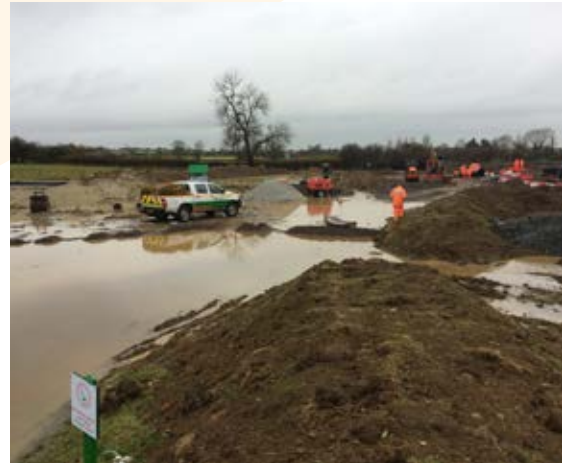
Figure 29

Washout failure and adjacent field at Chipping Sodbury Aqueduct (SWB 103m 74ch Dn)

Due to the relatively drier weather in CP5 in comparison to other control periods, in addition to targeted earthwork drainage enhancements over the last control period, there were fewer earthwork failures in total with no failures similar to the magnitude of which occurred in Teignmouth in CP5. Numerous smaller scale washouts and slope failures have occurred as a result of heavy and prolonged rainfall, including the slope washout at Chipping Sodbury Aqueduct and washout at level crossings in the Golden Valley, near Stroud.

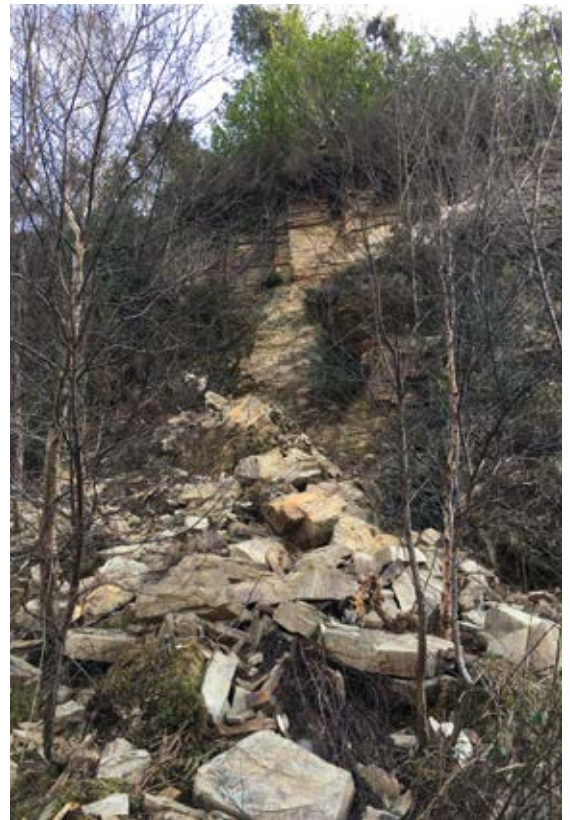
**Figure 30**

Rockfall failure occurring on MLN3 in 2018

Rock cutting failures can occur quickly with very little warning (known as brittle failure) and can have catastrophic circumstances. During CP5 there were a number of these incidents on the Western Route. Freeze-thaw within rock cuttings can cause issues, by increasing the dilation of the joints which can in turn lead to failure. Below shows evidence of the damage that can be caused by just a light rain and a prolonged period of temperatures below zero.

There was also a large presence of vegetation on the rock face causing root jacking to occur which will have contributed to the planar failure.

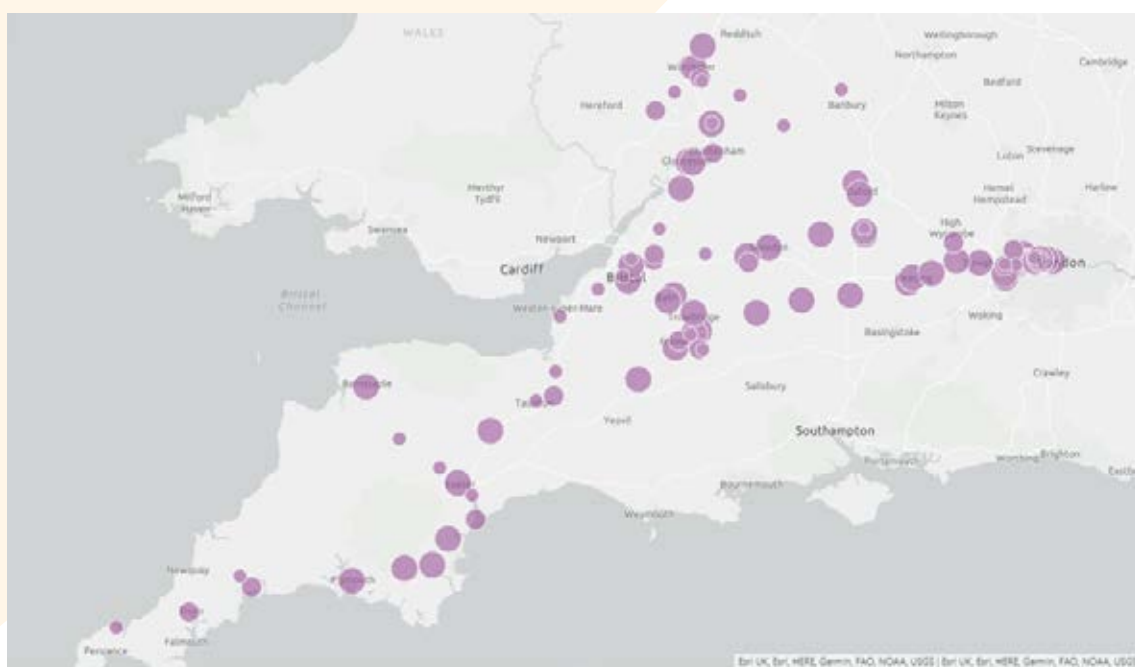
Figure 32

Heat related incidents in CP5 (2014/15 – 2018/19)

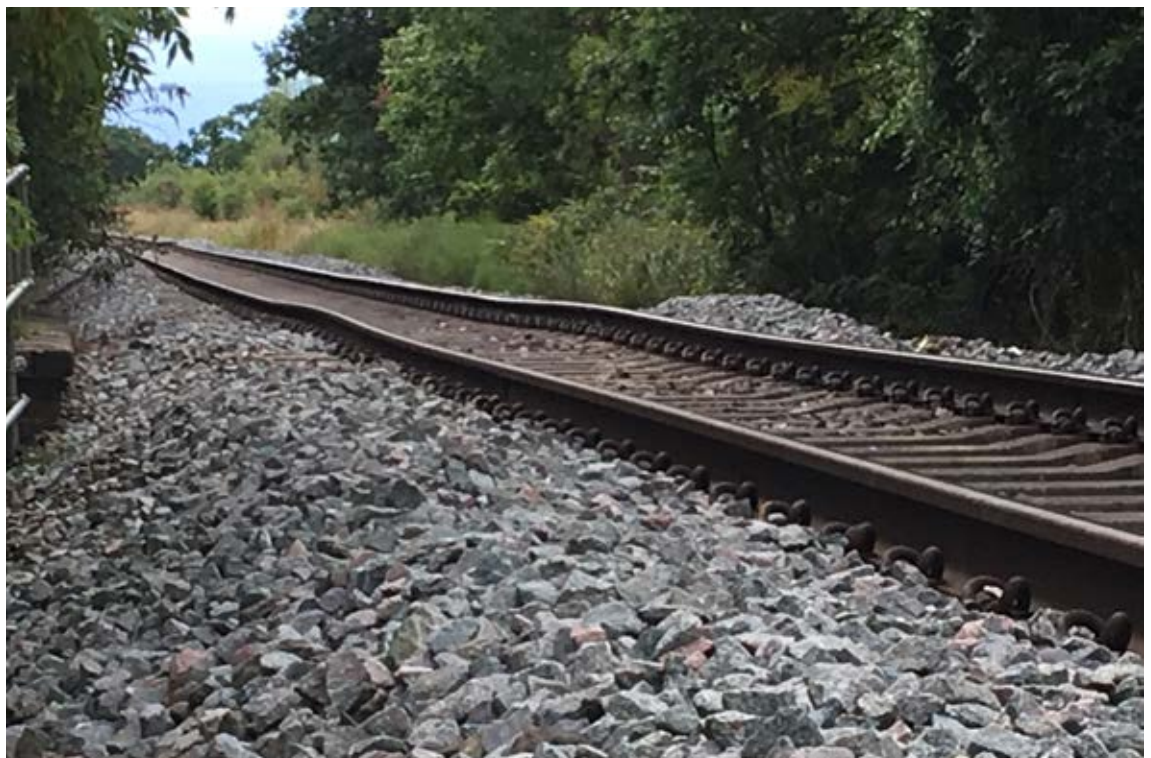
Figure 33
Poor track geometry
due to heat impact

The rails are vulnerable to the effects of heat as the rail expands and induces additional forces into the track system.

The expansion of steel rails in hot weather is accommodated either through gaps at the end of jointed rails or through a pre-tensioning or stressing of continuously welded rail. Both scenarios are closely managed with any deficiencies corrected in the spring.

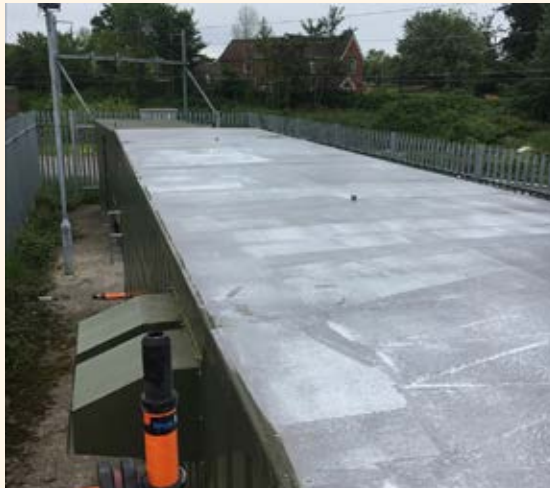
Figure 34

PSP roof painted with reflective paint to reduce solar gain

Uninterruptable Power Supplies (UPS) batteries are susceptible to heat; ideally, they should be kept at a steady 20°C and historically they have been kept in air-conditioned environments. Current policy however for Principal Power Supplies (PSPs) supplying signaling power to lineside equipment is to rely on forced air cooling. This relies on air at ambient outdoor temperature to cool equipment rooms and during the warmer months temperatures within these rooms are inevitably higher than ideal. The effects of heat on batteries is to reduce their operational life. The warmer the environment they are kept in the sooner they will need to be replaced. All battery rooms are fitted with high temperature alarms. We are experimenting with painting equipment room roofs with reflective paint to reduce solar gain and fitting full remote temperature monitoring to better respond to high temperature incidents.

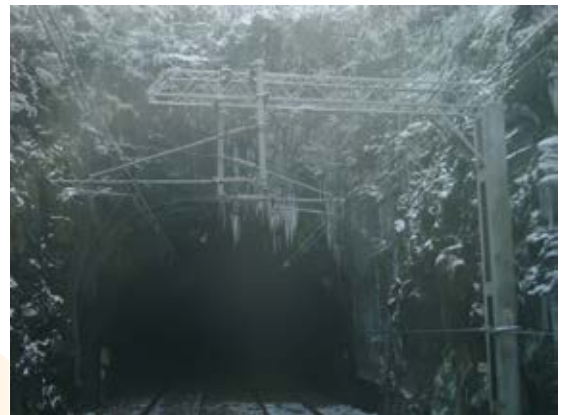
Figure 36
Icicles formed around OLE equipment,
(note –picture not on Western Route)

Automatic OLE tensioning also accounts for contraction in cold weather; current design allows for ambient temperatures down to -18°C. Icicles tend to form around the OLE at tunnel portals which can damage pantographs, as such maintenance teams must be sent out to knock these down in cold weather.

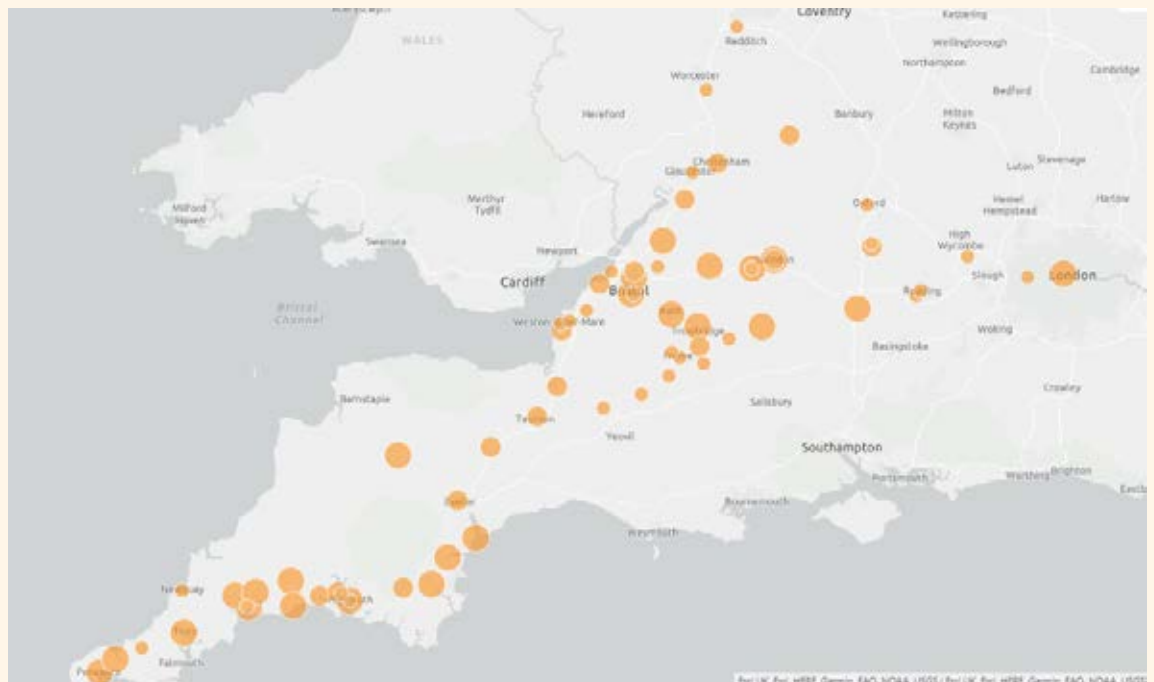
Figure 37

All flooding related incidents in CP5 (2014/15 – 2018/19)

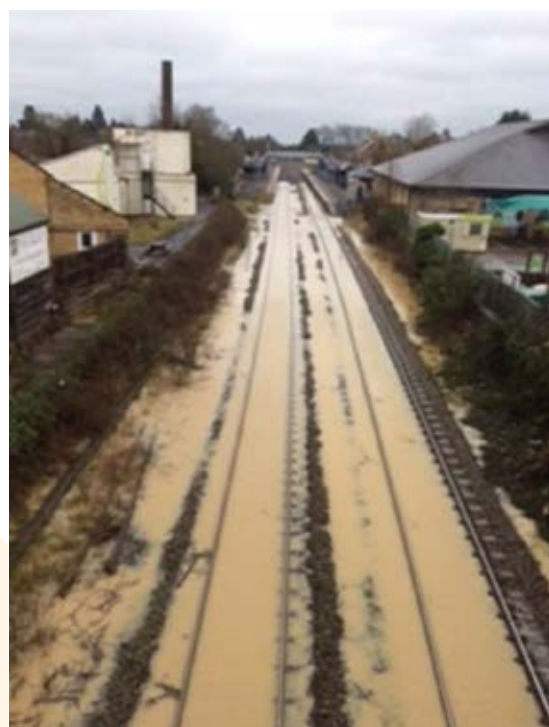
Figure 38
Moreton in Marsh (Storm Katie 2016)

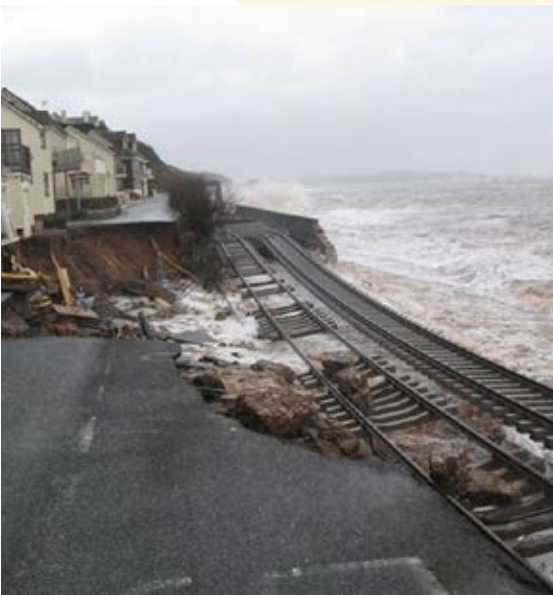
Figure 39
Damage caused by the storms in 2014 in Dawlish

Dawlish sea wall was overtopped in 2014, causing water to wash out fill and the wall to fail resulting in loss of support to the track and numerous areas of damage to the coping stones and boundary wall. New vulnerabilities are likely to develop due to the projected sea level rise.

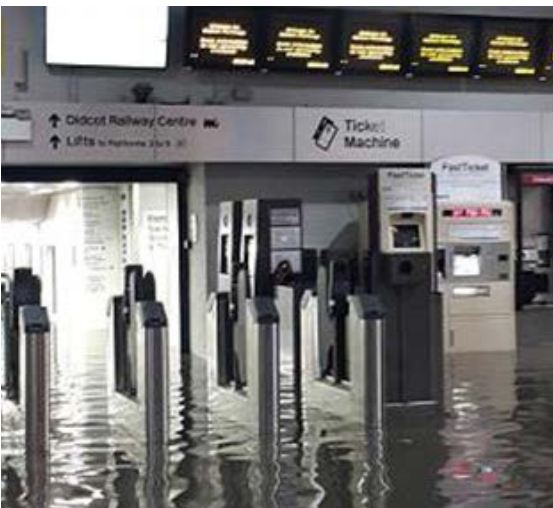
Figure 40
Flooding at Didcot Station

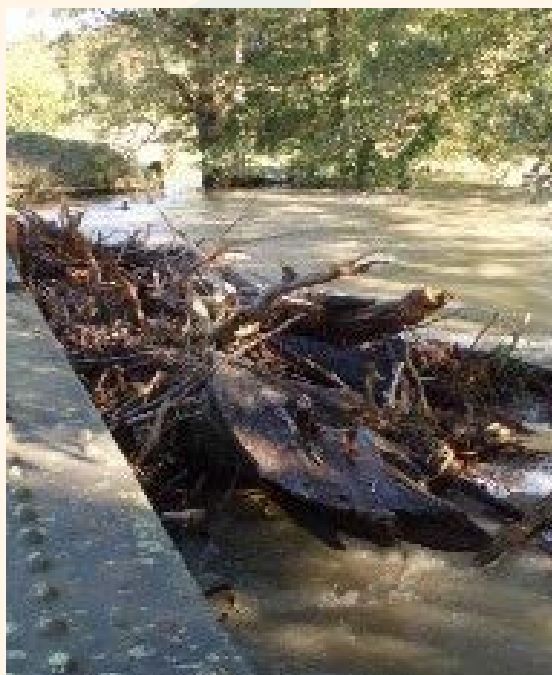
Figure 41
Debris washed up
against a metal
bridge deck

During flood conditions river levels rise to an extent where the openings of bridges and culverts run at full bore – this can give rise to dangers. Particularly at risk are metal bridge decks that may be displaced by the force of the water itself or debris carried downstream. When enclosed culverts run at full bore, the water can be put under pressure and hydraulic capacity can be reached. This can lead to water backing up, causing further flooding upstream with attendant dangers.

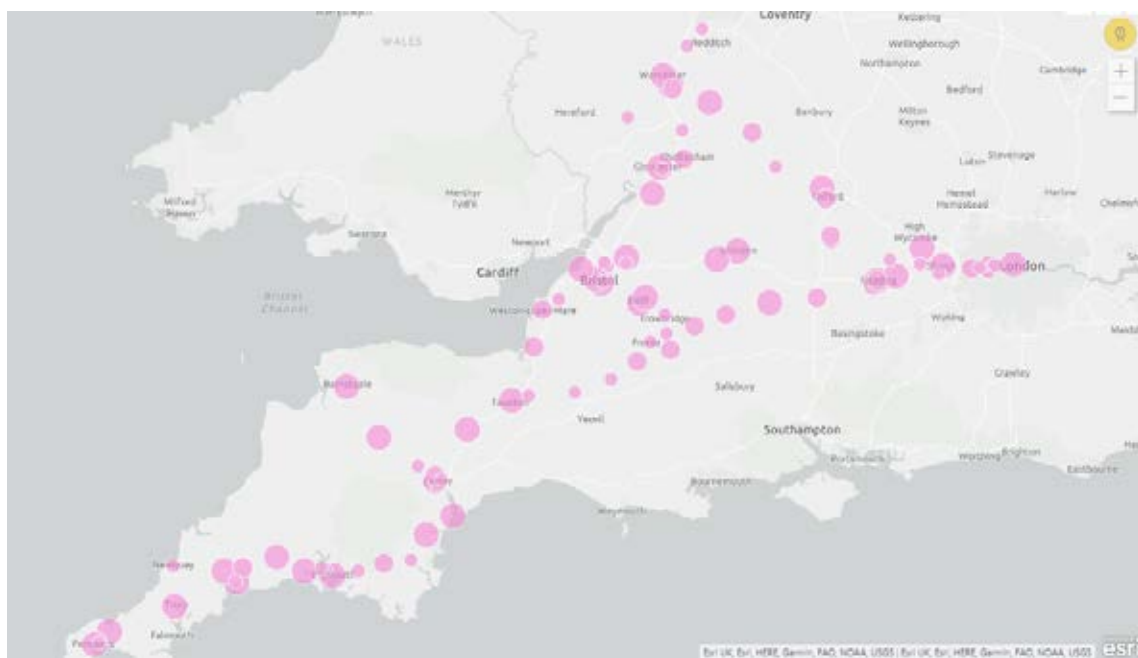
Figure 42

All wind-based incidents throughout CP5 (2014/15 – 2018/19)

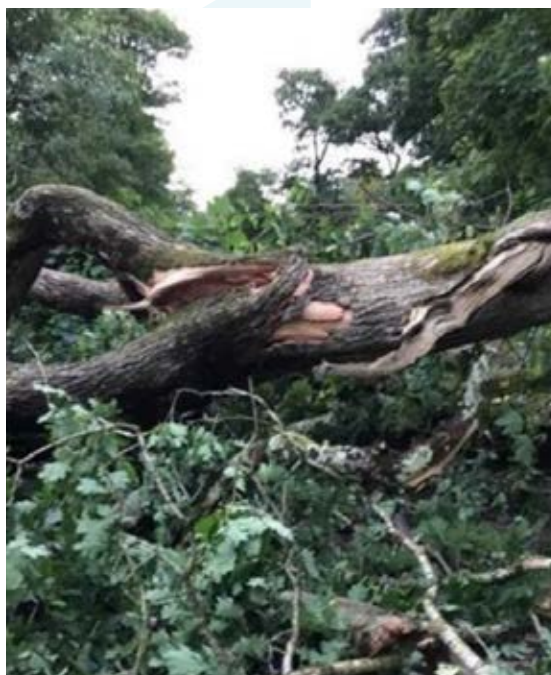
Figure 43
3rd party tree
obstructing the
LOO Line, June 2019

The impact of wind on vegetation can affect the running of railways in different ways. One of the most common causes is through leaves being blown onto the line, whether it be from trees within the Network Rail boundary or from third party land, this persistently causes a significant percentage of annual delay minutes. Another is a more serious and direct risk to safety due to potential derailment; the force that wind can create when acting on a tree could cause it to collapse onto the line, which, if not detected in time, could lead to a collision and derailment. Fallen trees can damage or destroy boundary fences raising opportunity for trespass – notably from livestock.

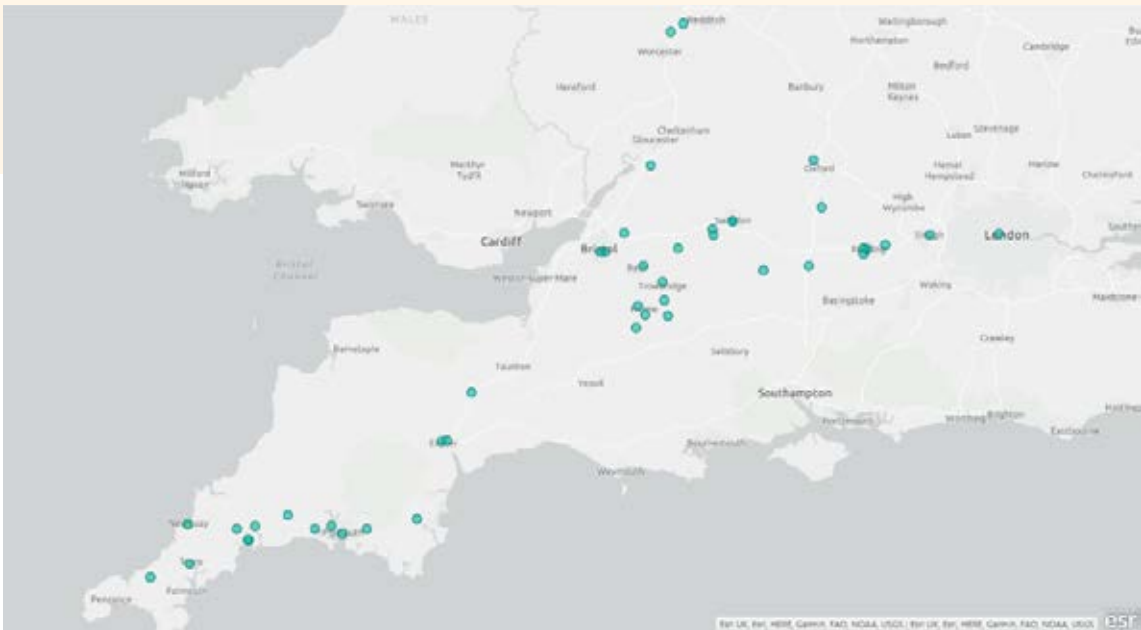
Figure 44
All lightning related incidents throughout CP5 (2014/15 – 2018/19)

The Route experiences a high number of lightning incidents in comparison to other Routes. Cornwall is particularly prevalent for lightning strikes, accounting for 50 per cent of the lightning strikes in the Route over the past eight years, primarily due to the granite-based geology and extremely high soil resistivity. Climate change projections are not available for lightning strikes, however as storm events are likely to increase in intensity and frequency, lightning will also potentially increase; however, this remains unpredictable.

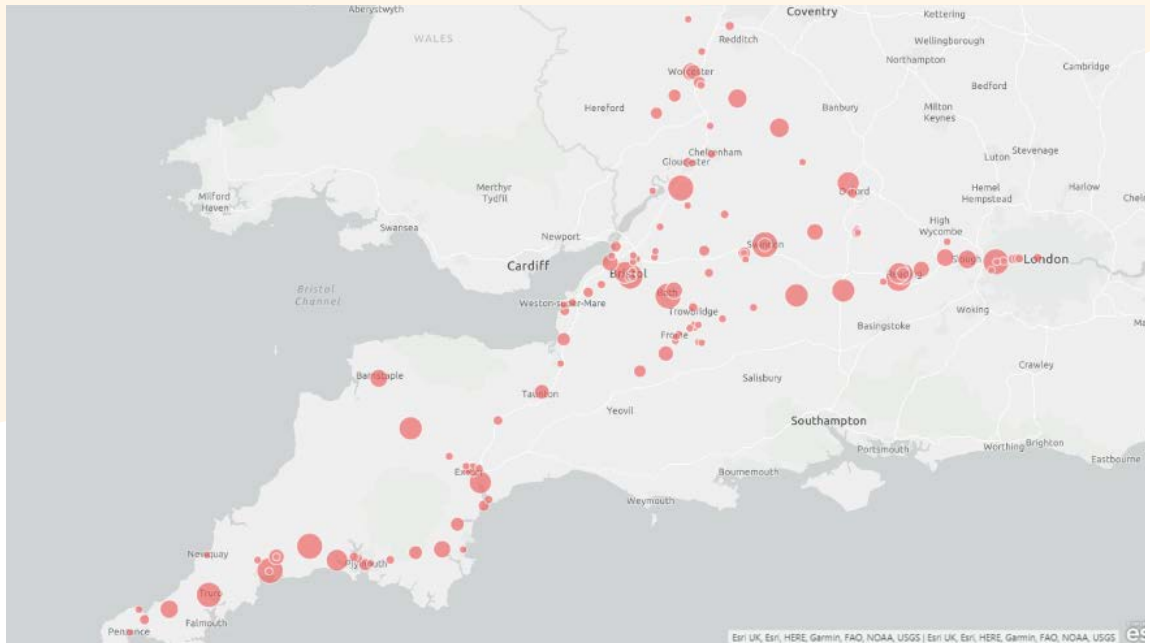
Figure 45

All incidents regarding adhesion in CP5 (2014/15 – 2018/19)

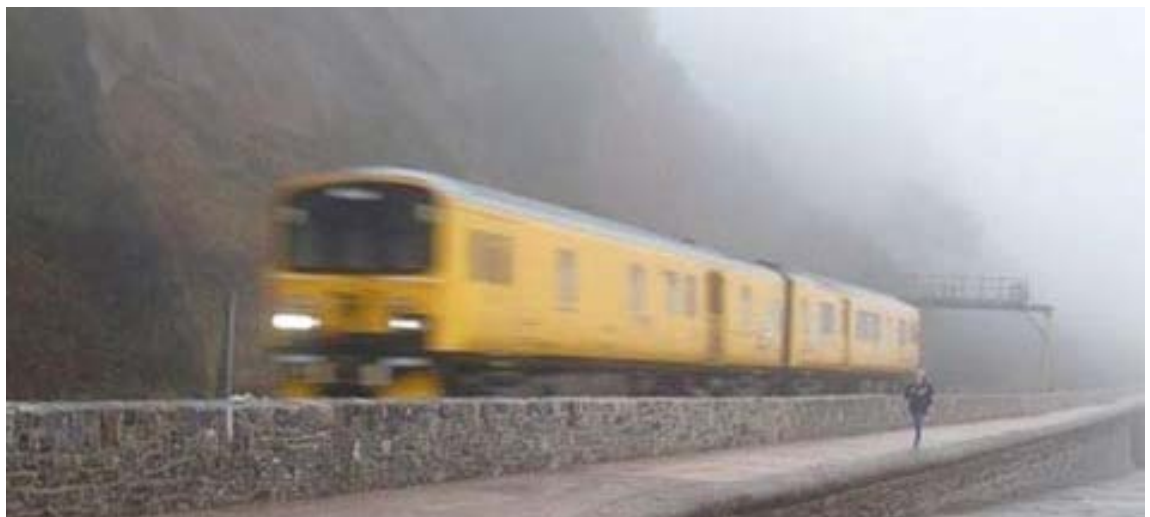
Figure 46

The Worcester area is still predominantly signalled by semaphore signals and therefore can still be significantly affected by foggy conditions. The resignalling of the Worcester area is programmed for CP6, which will reduce the impact of fog on the Route.

Fog in South Devon (Feb 2017)

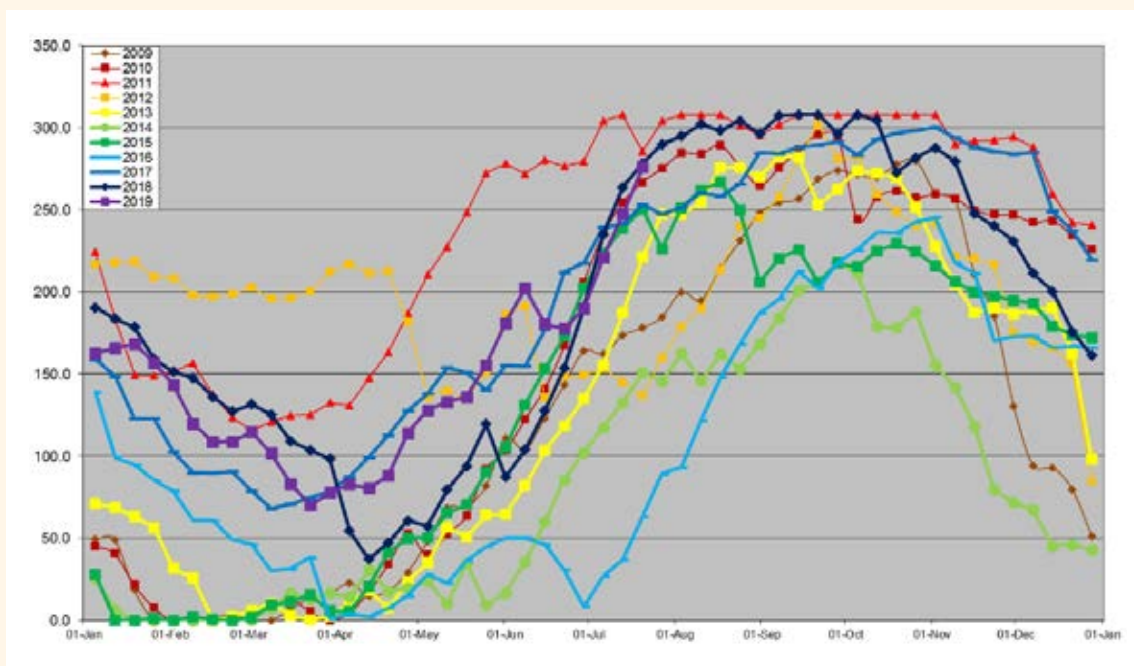
Figure 47

Example of SMD¹⁴ analysis currently undertaken in the Route

¹⁴SMD is a measure of how much water the ground can absorb before reaching its maximum field capacity, the higher the calculated number the drier the soil profile. SMD is calculated by the Met Office at 40km² grids and considers a range of factors that include rainfall, solar intensity, wind exposure and vegetation cover.

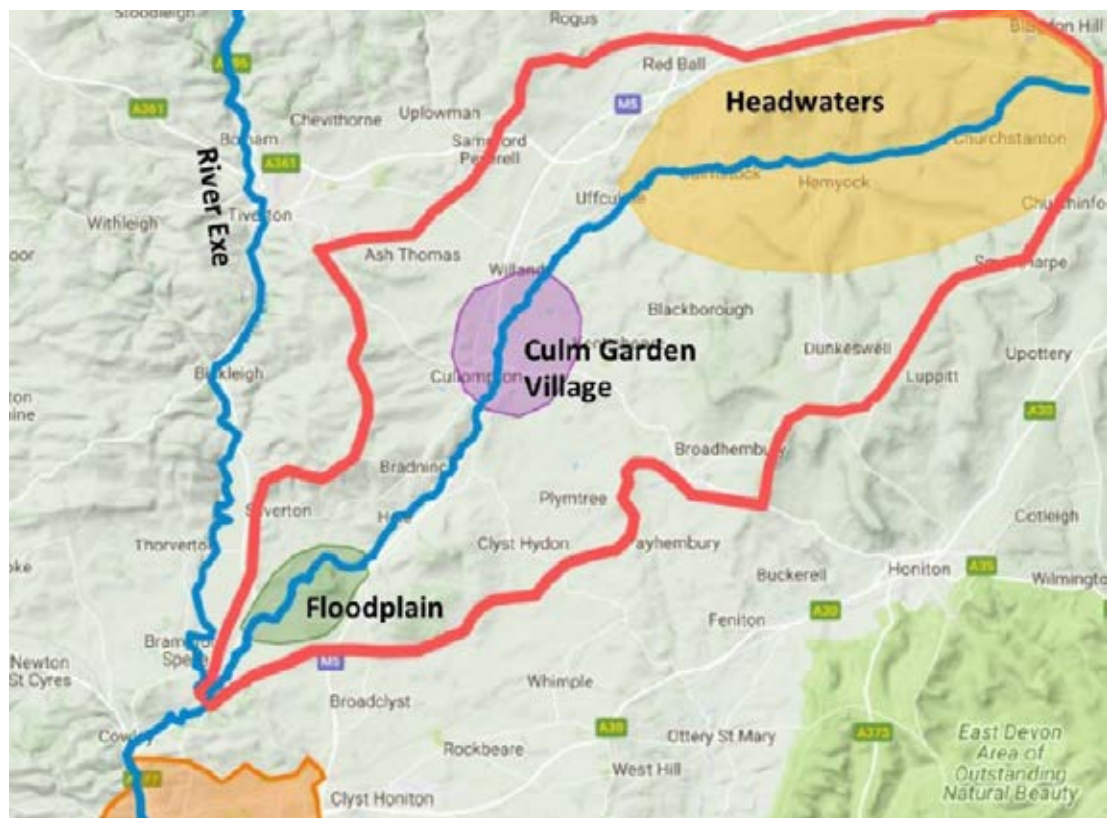
Figure 48
Image showing
extent of Connecting
the Culm

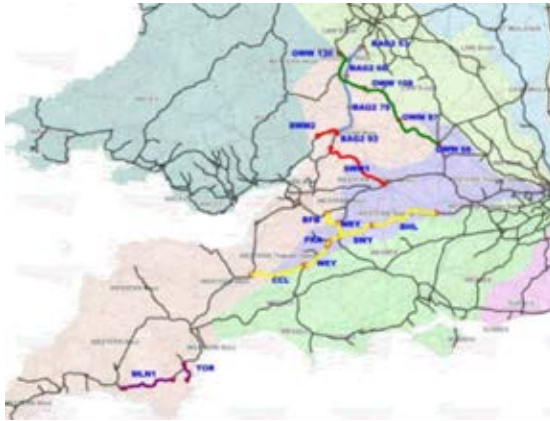
Figure 49

Map showing CP6 vegetation removal extents

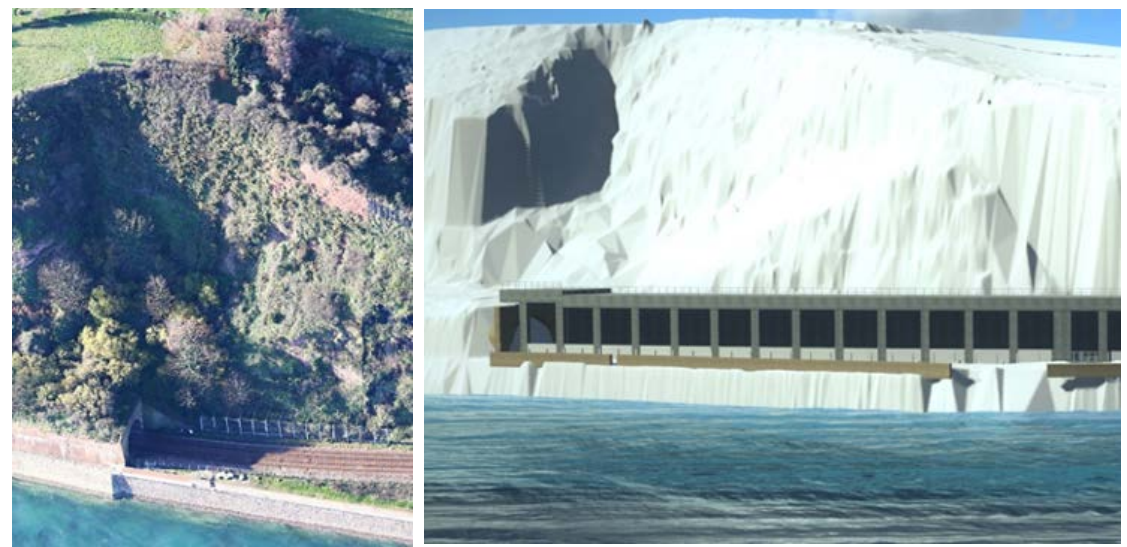
Figure 53

Current image of the CBU17 and Parsons Tunnel portal (left) and Mock-up of rock fall shelter solution at CBU17 (right)

CBU17 covers the cliffs around the low mileage entrance into Parsons tunnel where there is substantial risk of rock slope failure due to its natural fall towards the railway, the formation of a gully around the tunnel portal and the risk of erosion of the cliff face in large storms. The proposed resilience scheme is to construct a rock fall shelter which will protrude for 85m out of Parsons Tunnel running along the base of the cliff face, accompanied by soil nailing and netting of the upper.

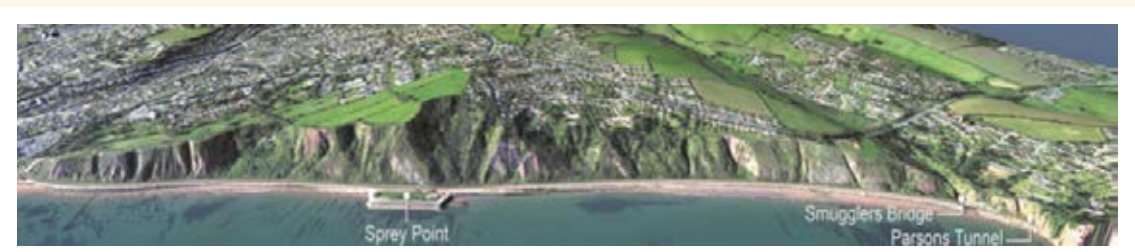
Figure 54

The repositioning of the track away from the cliffs will allow for a series of buttresses to be constructed at (CBU 4,6,8,10 and 12) to reinforce the high-risk cliffs situated behind them. Other areas will be strengthened by large dowels to prevent a large wedge failure and a rock fall shelter will be installed to the high mile (west) of Parsons tunnel to protect the line from the cliffs around the portal.

Extent of Parsons Tunnel to Teignmouth Site (Arcadis, 2019)
