Information request

Reference number: FOI2018/0602 & FOI2018/00603

Please may I request the following Level Crossing Narrative Risk Assessment's

Please may I request the following Level Crossing Narrative Risk Assessment:

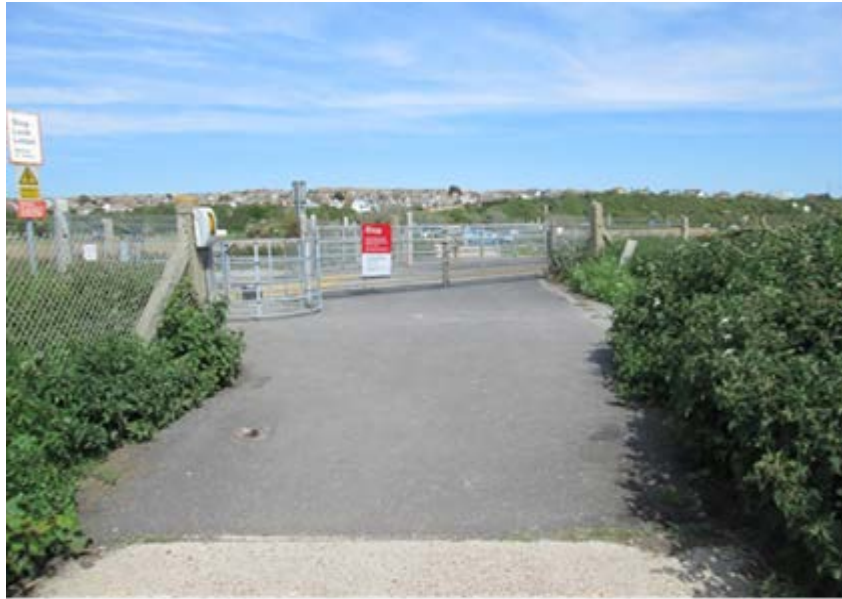
Up side crossing approach

The decision point is the same on both sides at 3m which is measured from the nearest running line back and the 7.2m traverse length for the crossing is measured on the skew which is the direct preferred travelling route for a vehicle.

The pedestrian walking route is further highlighted and encouraged by the installation of yellow high viz anti slip matting which covers the timber crossing deck and encourages separation from the vehicle traverse section of the crossing. The vehicle section of the crossing does not have any additional anti slip installed as it is not required.

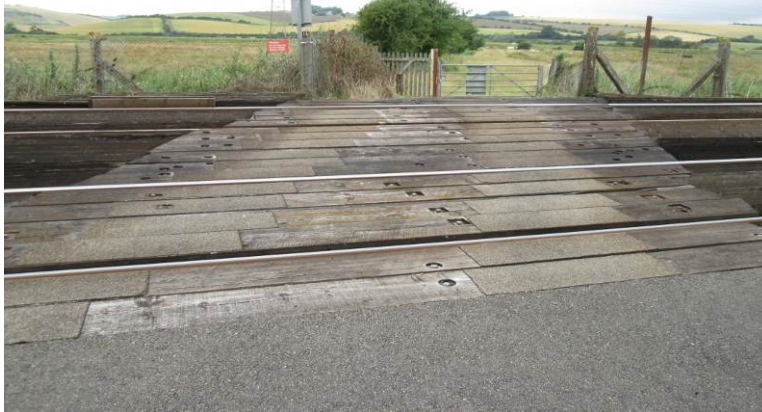
Down to up side showing wooden deck and additional anti slip for users.

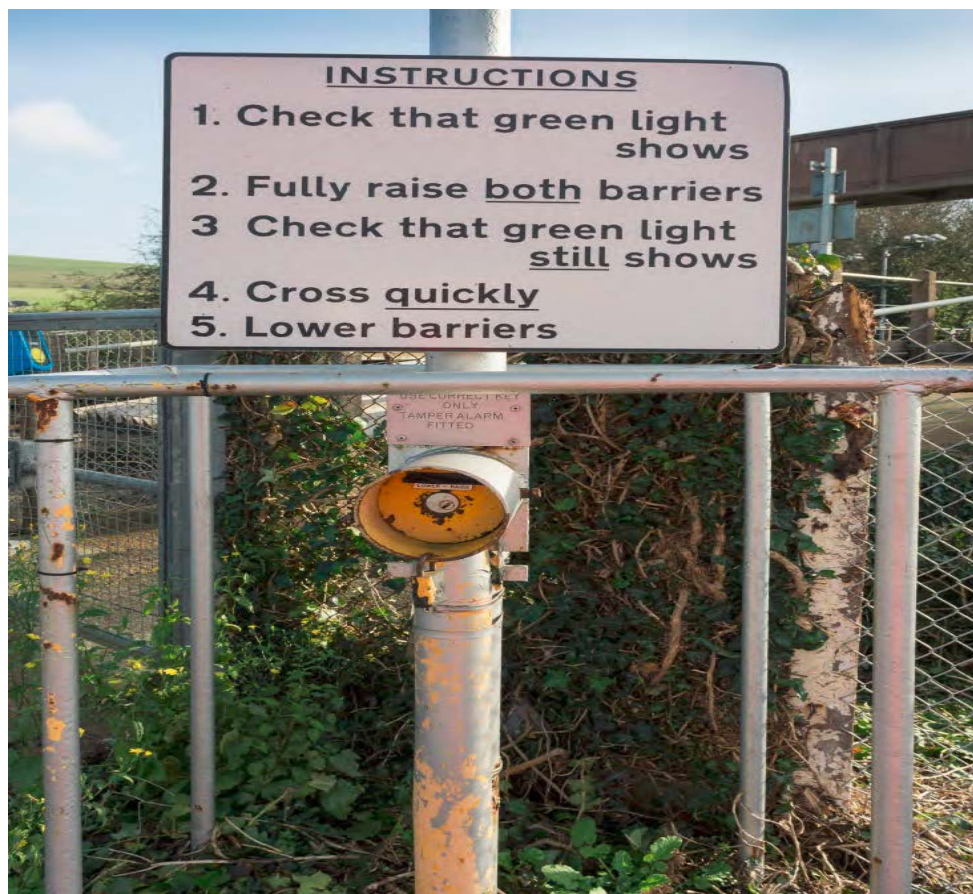
Example of one of the 4 key locks to open the crossing

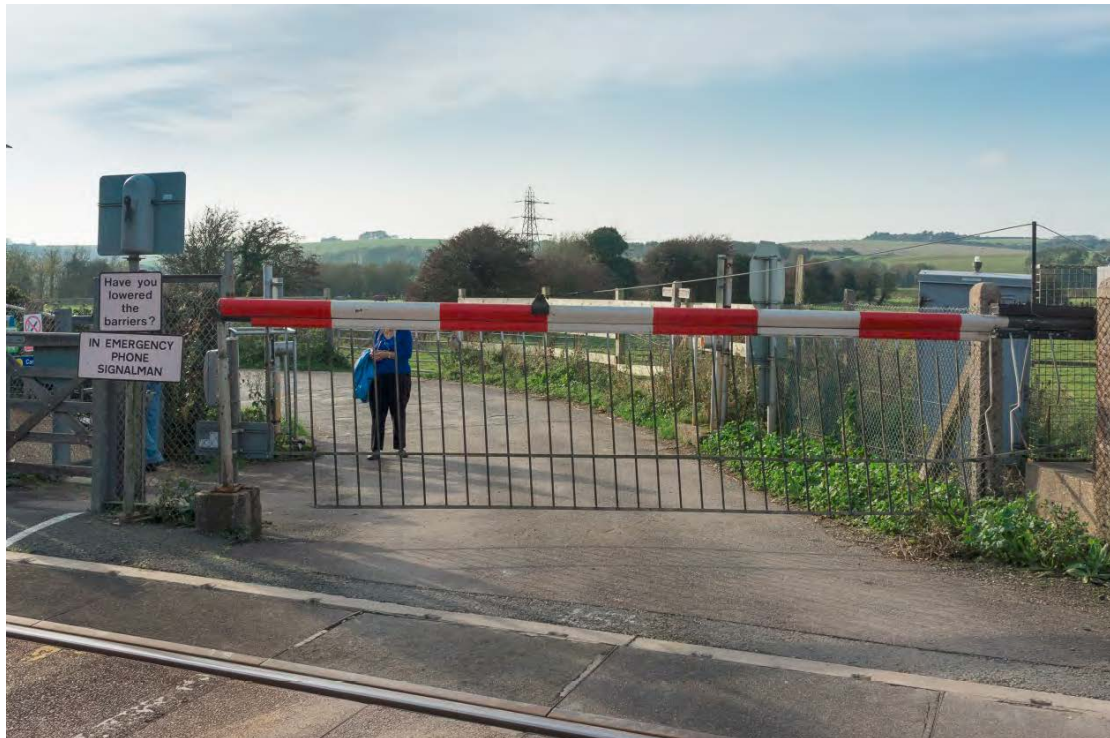
Shows location of the 2 key locks on the up side
